Maitland Heritage Conservation District:
Changes to the Built Environment since the creation of
the 1995 Maitland Heritage Conservation Plan & Bylaw

Bachelor of Community Design, Urban Design Thesis Project
Alyssa te Bogt
Supervisor: Kate Thompson
Dalhousie University
April 9, 2014

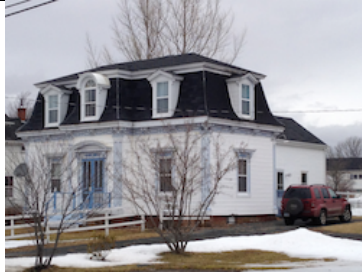
Changes: Picket fence replaced with simpler fence. Chimneys removed. Paint.

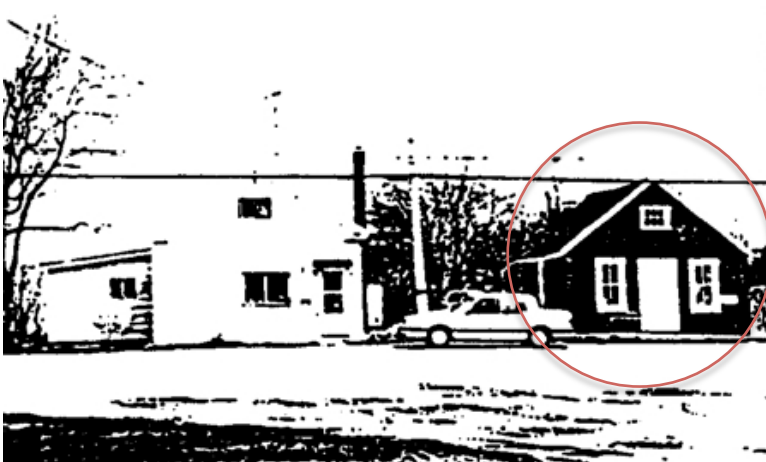
[Figure 4] Demolished Building 1

The building circled in red [Figure 4] was located on Highway 215 next to the old customs and telephone office. The location of the house in [Figure 5] is unknown given the poor quality of the image, but it is thought to have been located on Maple St, as the a map of historic buildings in the *Maitland Heritage Conservation District Plan & Bylaw* shows a historic building on that street where one currently does not exist (*Maitland Heritage Conservation District Plan & Bylaw*, 5.)

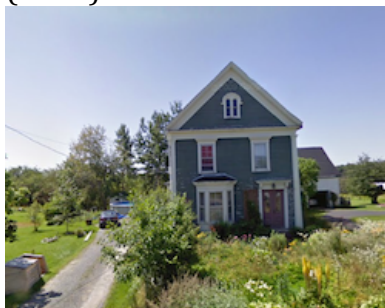
Changes: Above ground swimming pool added. Paint color changed. Chimney removed.

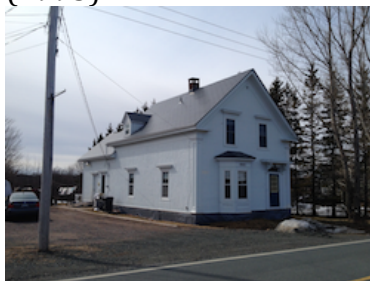
Changes: Front step removed. Paint & shingles. Foundation work. Front door replaced.

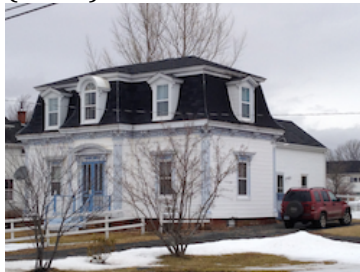
Changes: Picket fence replaced with simpler fence. Chimneys removed. Paint.

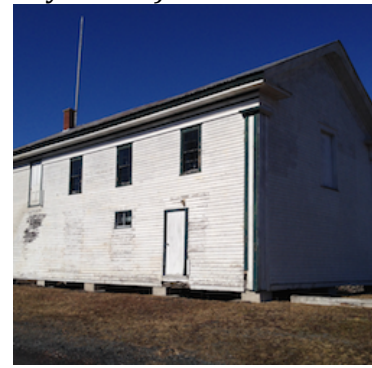
Changes: Building has had to be moved south of its original location due to sea level rise. Exterior staircase removed.

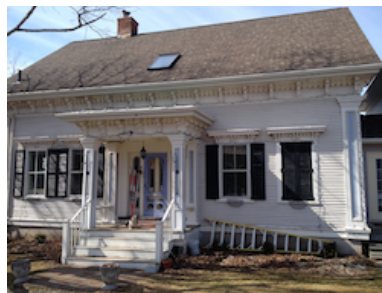
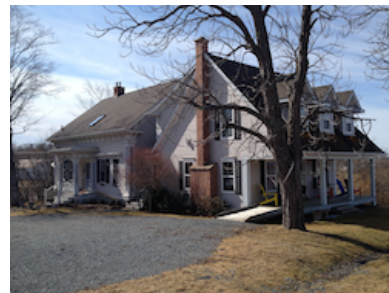
Changes: Very large cape cod addition constructed on east side of house, overlooking the Schubencadie River. Paint.

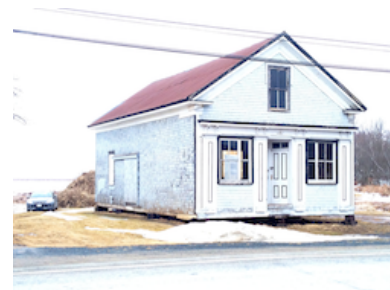
Changes: Building has had to be moved north of its original location due to erosion.

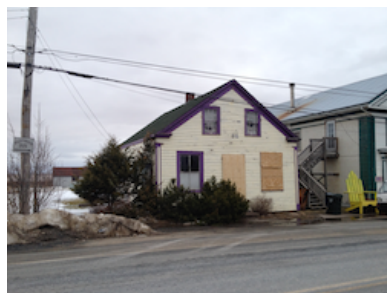
Changes: Building has gotten steadily more run down and boarded up.

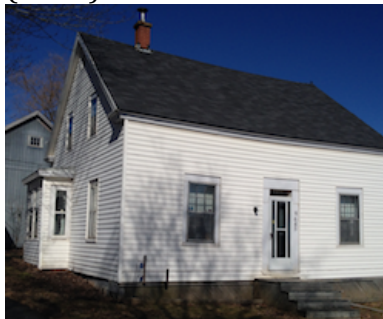
Changes: Resided.

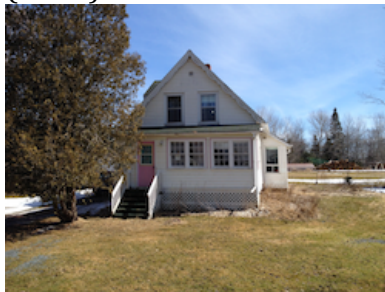
Changes: Front porch enclosed.

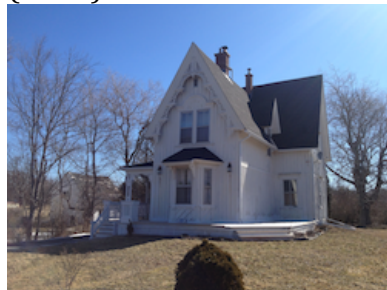
Changes: Front deck restored and expanded.

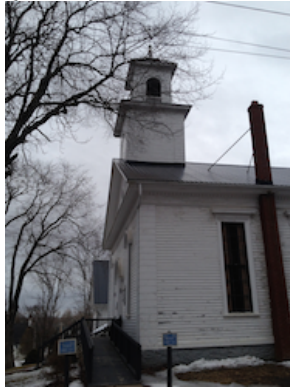
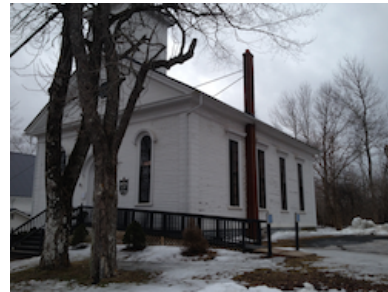
Changes: New front step with ramp on both structures.

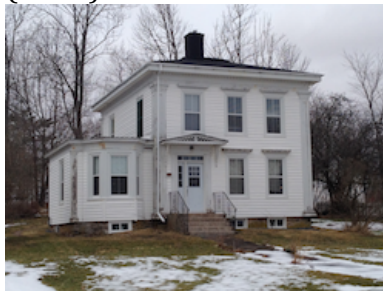
Changes: Shutters Removed. Paint. Balcony above side ell removed.

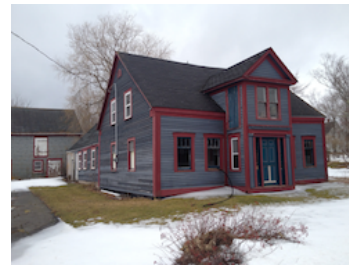
Changes: Front central windows were replaced with a capped door with sidelights. Paint.

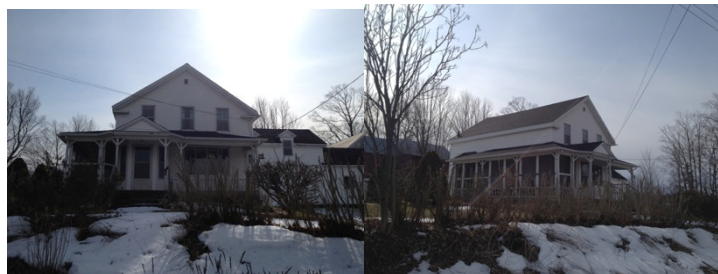
Changes: Chimney removed. Veranda enclosed. Paint.

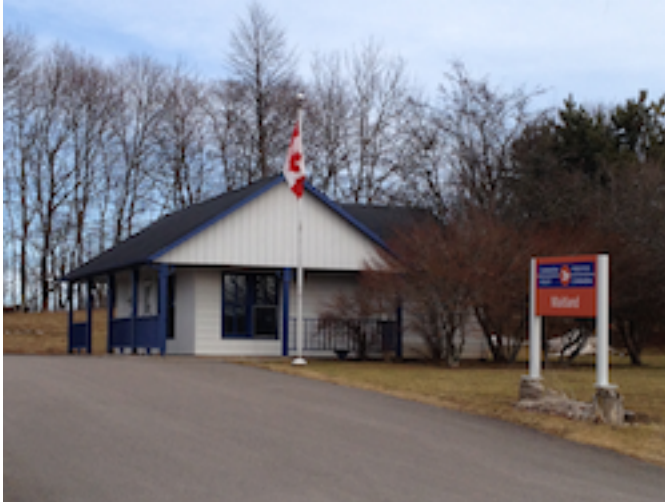
1

The post office and the fire hall are both centrally located in Maitland and neither fit the guidelines set out in the Conservation Plan particularly well. Even though the fire hall is not actually within the Conservation District I would recommend that if exterior work was ever deemed necessary for either building that the Design Guidelines set out in the Conservation Plan be taken into consideration.

Canada Post Office. Inside the Conservation District boundary. Built pre-1995.

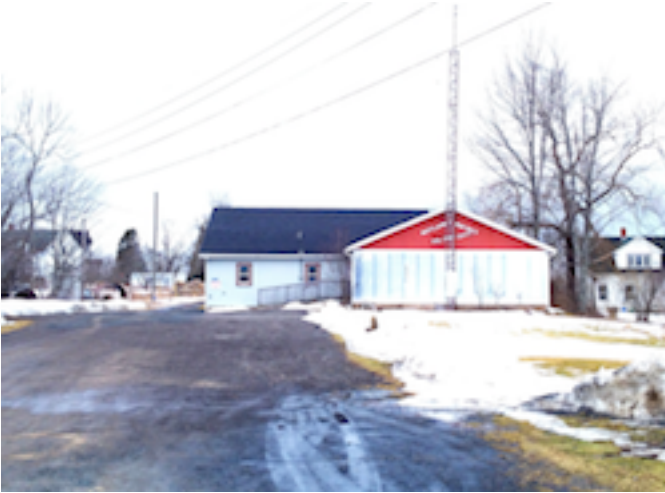
3

Maitland Volunteer Fire Department. Built pre-1995. Outside Conservation District boundary.

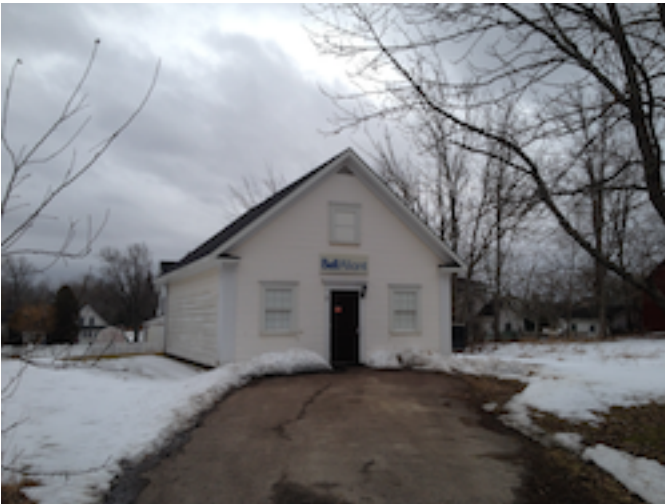
6

BellAliant Building (built post-1995.) Within Conservation District boundary. Effort was clearly taken to adhere to the design guidelines set out in the *Maitland Heritage Conservation District Plan & Bylaw*.

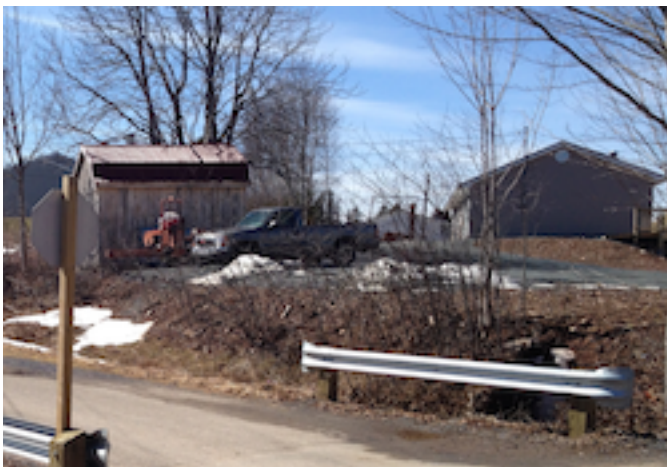
9

Modern residence built inside Conservation District boundary post 1995. As per the map on page 21 of the *Maitland Heritage Conservation District Plan & Bylaw*, it appears to have been built on the site of a historic residence.
