## **East Hants – Servicing Capacity Study**

### **Technical Memorandum #6 – Stormwater Culverts Assessment Draft**

**RVA 226421**

**May 5, 2023**

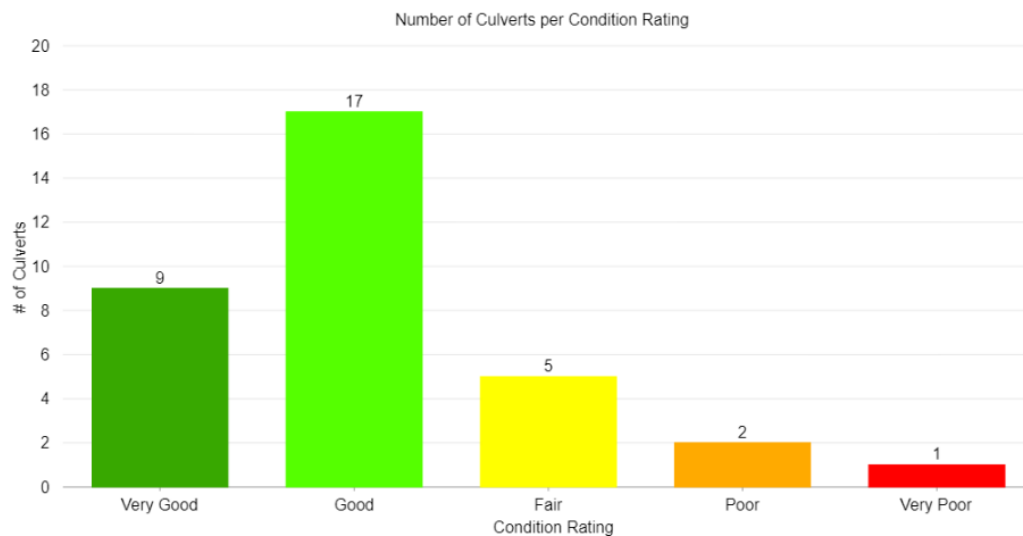
Figure 2.1 – Number of Culverts per Condition Rating

Based on the condition assessment inspections performed in the field, the stormwater culverts along Highway 2 are generally in good condition. All concrete culverts are in good condition however, some of the corrugated steel culverts should be considered for replacement. **Appendix B** includes all inspection forms with comments and photos to showcase the condition of the culverts and conditions in the upstream and downstream areas. The results of the condition assessment are also summarized in **Figure 2.1** below.

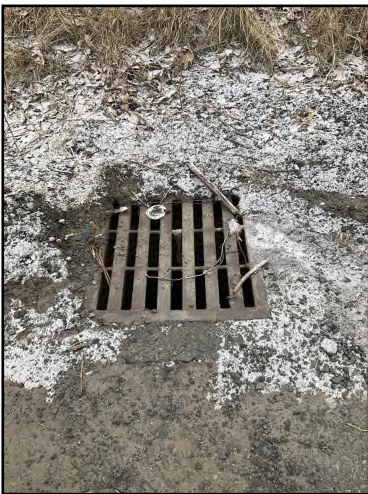
**Asset ID :** 43  
**Date of Inspection :** March 17, 2023  
**Culvert Diameter :**  
**Barrel Type/Material :**  
**Overall Condition Rating :** Very Good  
**Comments :** Replaced by storm sewer

Photo 1: Catch basin on East side of Highway 2.

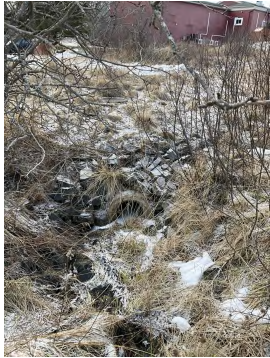
**Asset ID :** 45  
**Date of Inspection :** March 17, 2023  
**Culvert Diameter :** 600mm  
**Barrel Type/Material :** Concrete  
**Overall Condition Rating :** Fair  
**Comments :** Downstream channel filled with vegetation. Water level at obvert.  
Area behind post office flows to SE swale.

Photo 1: Culvert flowing from Enfield Manor

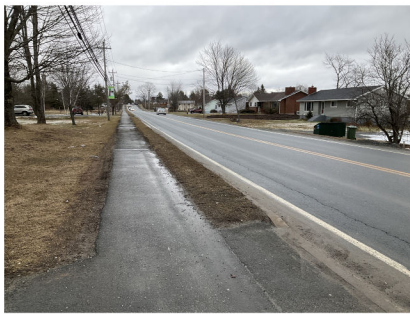
**Asset ID :** 47  
**Date of Inspection :** March 17, 2023  
**Culvert Diameter :** 600mm  
**Barrel Type/Material :** Galvanized Steel  
**Overall Condition Rating :** Very Poor  
**Comments :** Downstream channel is full of sediment. Water level 180mm below obvert. Barrel corroded. Rock headwall is falling down. Upstream manhole is in asphalt sidewalk. Catch Basin on lawn draining to culvert.

Photo 1: Cross-section of road above culvert

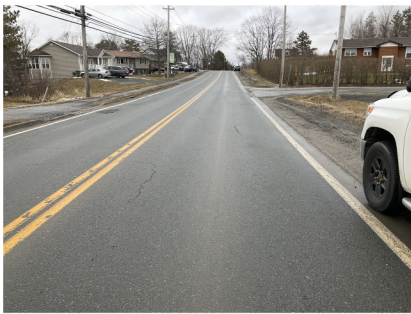
**Asset ID :** 48  
**Date of Inspection :** March 17, 2023  
**Culvert Diameter :** 900mm  
**Barrel Type/Material :** Concrete  
**Overall Condition Rating :** Good  
**Comments :** Barrel is in good condition. Pooling at outlet, no backwater DS. US grass and vegetation growth. Stone head wall recently restored. Landowner states culvert does not have capacity to convey flow. During February rainfall, culvert was 3/4 full at times.

Photo 1: Cross-section of road above culvert

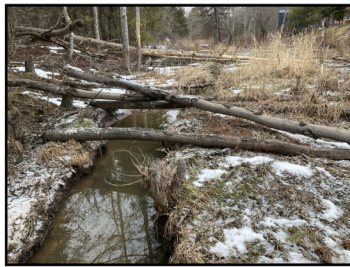
**Asset ID :** 49  
**Date of Inspection :** March 17, 2023  
**Culvert Diameter :** 1500mm US, 600 x 1300 DS  
**Barrel Type/Material :**  
**Overall Condition Rating :** Good  
**Comments :** 900mm open above debris. Downstream headwall is leaning, Upstream headwall is in good condition. Shoulder washing away above outlet of culvert. High amount of debris in downstream channel.

Photo 1: Upstream channel

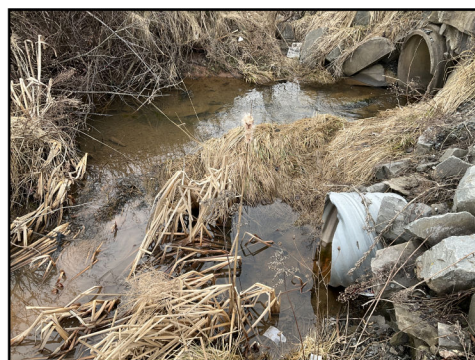
**Asset ID :** 52  
**Date of Inspection :** March 17, 2023  
**Culvert Diameter :** 750mm concrete, 600mm steel, 450mm concrete US  
**Barrel Type/Material :**  
**Overall Condition Rating :** Good  
**Comments :** Minimal high water mark on both culverts. High amount of debris in downstream channel. Gravel inside of upstream end of culvert. Storm sewer on west side connected to culverts.

Photo 4: Vegetation growth at outlet of culverts

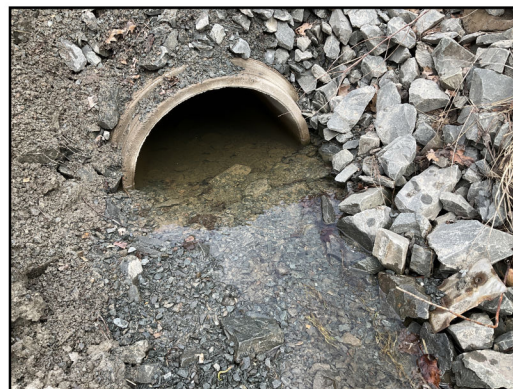
Photo 2: Gravel deposits at outlet of culvert

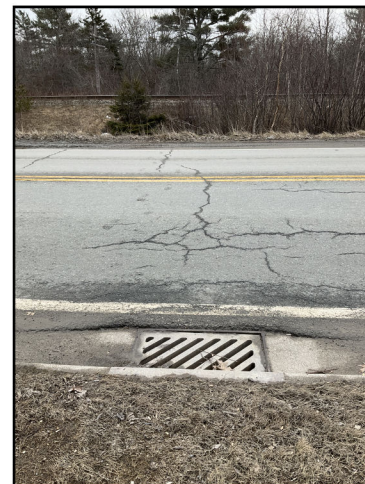
Photo 3: Catch basin connected to culvert with cracking across road

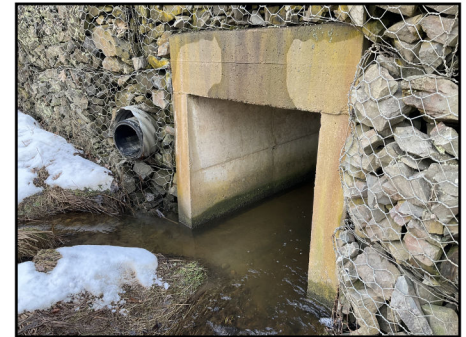
**Asset ID :** 60  
**Date of Inspection :** March 17, 2023  
**Culvert Diameter :** 1250 x 1280  
**Barrel Type/Material :** Concrete Box  
**Overall Condition Rating :** Good  
**Comments :** Culvert clean with no blockages. Upstream retaining wall leaning. Downstream headwall corroded. Wetland upstream.

Photo 3: Upstream head-wall

Asset ID	Issues	Recommendations
45	Downstream channel blocked with vegetation	Remove debris and vegetation from downstream channel
47	Insufficient capacity for both 5-year and 100-year storm events	Consider for replacement
48	Vegetation growth in upstream channel. Insufficient capacity for 100-year storm event	Consider for replacement
49	Debris in downstream channel	Remove debris from downstream channel
50	Debris & sediment build-up at outlet	Remove debris and sediment from outlet
52	Debris in downstream channel	Remove debris from downstream channel
54	Outlet obstructed	Remove debris from outlet
55	Debris built up downstream. Insufficient capacity for 100-year runoff event	Remove debris and consider for replacement
56	Debris build-up at outlet	Remove debris from outlet
59	Inlet blocked by haybales. Some debris downstream	Remove haybales and debris
60	Downstream headwall in need of repair	Repair headwall

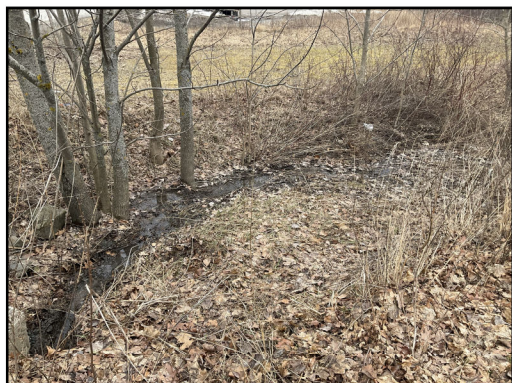
**Asset ID :** 61  
**Date of Inspection :** March 17, 2023  
**Culvert Diameter :**  
**Barrel Type/Material :**  
**Overall Condition Rating :** Fair  
**Comments :** Small culvert. Outlet between Highway 2 and railway. Pipe completely full of gravel except for top 100mm. Signs of high flow downstream. Local water moving after removing some gravel from pipe and channel.

Photo 1: Flow from culvert after clearing debris

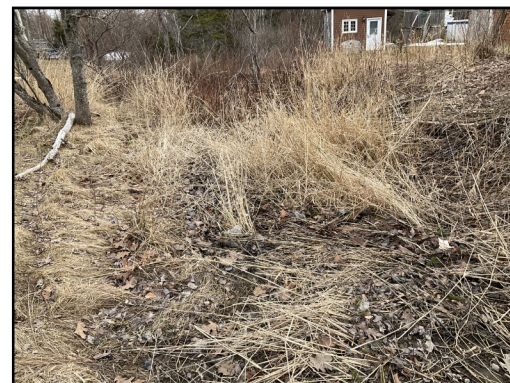
**Asset ID :** 63  
**Date of Inspection :** March 17, 2023  
**Culvert Diameter :** 900 x 750  
**Barrel Type/Material :** Concrete Box  
**Overall Condition Rating :** Good  
**Comments :** No flow, sediment on bottom of culvert. Concrete headwall with culvert structure. US pipe 450mm, connected to manhole. Big rocks inside of pipe and around pipe is blocking flow entrance. Grass buildup in channel. Storm sewer on west side with sidewalk.

Photo 3: Downstream channel

63	Debris build-up in culvert. Vegetation growth downstream	Remove debris and vegetation
65	Vegetation growth downstream	Remove vegetation growth
66	Debris in upstream channel	Remove debris
69	Debris build-up at both ends of culvert	Remove debris
69A	Insufficient capacity for 100-year runoff event	Consider for replacement
73	Vegetation growth on both ends of pipe. Insufficient capacity for 100-year run-off events	Remove vegetation and consider for replacement
74	Vegetation growth in both downstream and upstream channels	Remove vegetation growth

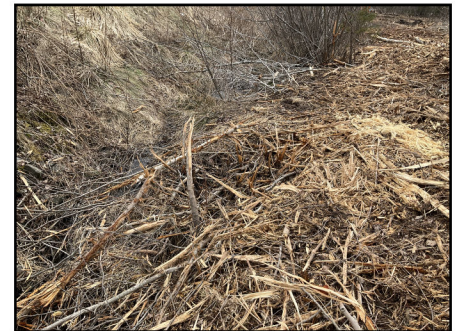
**Asset ID :** 66  
**Date of Inspection :** March 17, 2023  
**Culvert Diameter :** 900  
**Barrel Type/Material :** Concrete  
**Overall Condition Rating :** Good  
**Comments :** 600mm diameter upstream to MH, changes to 900mm out of MH. Riprap around sides and top of pipe. Downstream channel in good condition, bends to the south after discharge. 250mm drop to channel from culvert. Vegetation and rock blocking entrance.

Photo 3: Debris in upstream channel from brush cutting operations

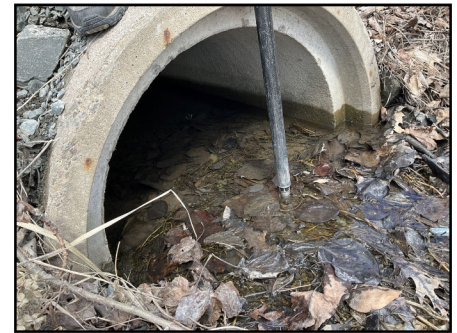
**Asset ID :** 69  
**Date of Inspection :** March 29, 2023  
**Culvert Diameter :** 750mm  
**Barrel Type/Material :** Concrete  
**Overall Condition Rating :** Good  
**Comments :** Upstream end blocked by downed tree. 300mm of bottom of culvert filled with debris, limited capacity. Good flow in downstream channel along laneway. Road above culvert has cracking. Asphalt walkway on east side.

Photo 3: Outlet of culvert

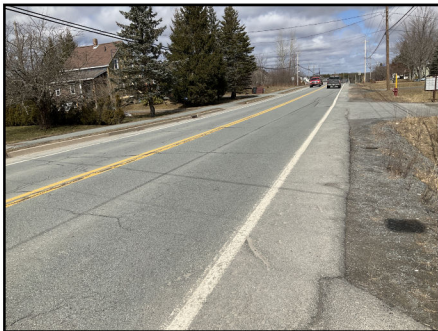
**Asset ID :** 70  
**Date of Inspection :** March 29, 2023  
**Culvert Diameter :** 600mm  
**Barrel Type/Material :** Concrete  
**Overall Condition Rating :** Fair  
**Comments :** Culvert half full of debris. Serves senior townhouse development upstream. Local ditch inlets in yards on North side. Asphalt walkway on west side with manholes. 200mm PVC pipe at west side of manhole to serve local yard. DS channel grown in with grass.

Photo 1: Cross-section of road above culvert

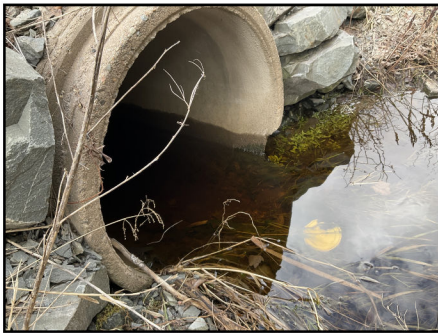
**Asset ID :** 73  
**Date of Inspection :** March 29, 2023  
**Culvert Diameter :** 750mm  
**Barrel Type/Material :** Concrete  
**Overall Condition Rating :** Good  
**Comments :** Stone installed to protect pipe on upstream side. Upstream channel grown over but flowing good with local ditching from woods. Downstream channel has little flow due to grass build up blocking channel. 100mm water depth in pipe.

Photo 1: Outlet of pipe with approximately 100mm of standing water in pipe

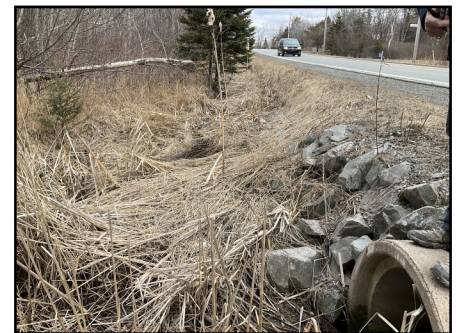
**Asset ID :** 74  
**Date of Inspection :** March 29, 2023  
**Culvert Diameter :** 750mm  
**Barrel Type/Material :** Concrete  
**Overall Condition Rating :** Good  
**Comments :** 320mm water level downstream. Upstream and downstream channels are overgrown. Local ditching on each side of culvert. At time of inspection, no development upstream.

Photo 3: Overgrown vegetation in upstream channel

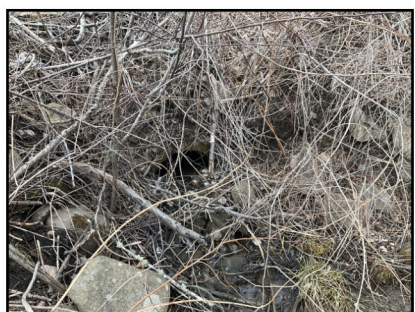
Although the CN culverts are a part of the capacity study only, RVA visually inspected three culverts along the CN railway. Two of these, CN23 and CN24 were in poor condition, with CN22 being full of gravel and the bottom corroded away. RVA has developed recommendations to be considered based on the condition assessments of each culvert along Highway 2, which can be found below.

**Asset ID :** CN 23  
**Date of Inspection :** March 29, 2023  
**Culvert Diameter :** 450mm  
**Barrel Type/Material :** Galvanized Steel  
**Overall Condition Rating :** Fair  
**Comments :** Culvert is buried with little flow. 250mm of culvert is filled with gravel.

Photo 1: Outlet of culvert

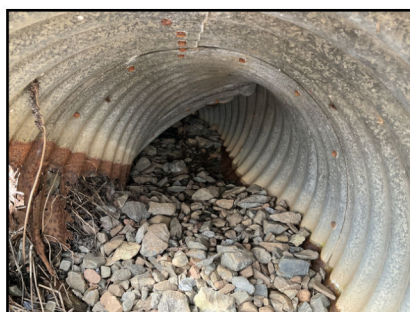
**Asset ID :** CN24  
**Date of Inspection :** March 29, 2023  
**Culvert Diameter :** 600mm  
**Barrel Type/Material :** Galvanized Steel  
**Overall Condition Rating :** Poor  
**Comments :** 200mm water level. Culvert collapsed under railway.

Photo 1: Inside of collapsed culvert
