July 12, 2024

**Re: CN Railbed Drainage - Damage Assessment
Stormwater Management - East Hants**

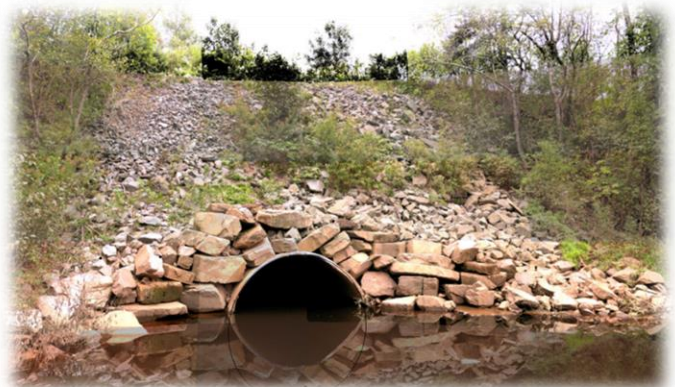
Figure 1 Inlet to CN Railbed Culvert (Oct 2023)

You have has an opportunity to review our opinion on inundation at Robert Scott Drive and surrounding areas on July 22nd 2023. At the time, we measured the CN culvert in Figure 1, located at the outlet for the Barney's Brook Watershed, a tributary of the Shubenacadie River, as a 3.3 m diameter culvert with invert elevation 7.59 m. We measured the top of the railbed at elevation 19.8 m.

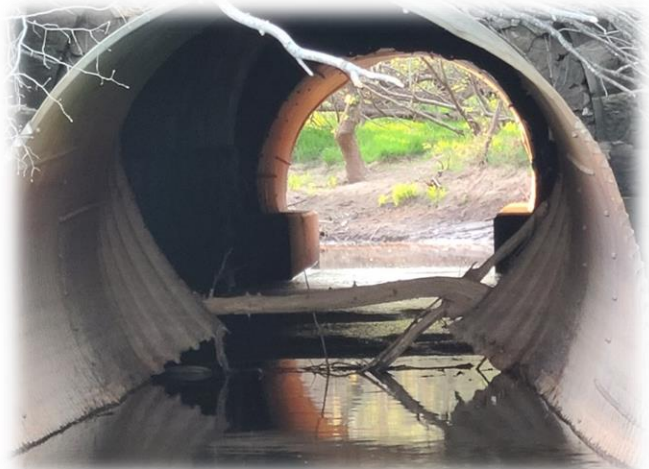
Figure 2 Outlet to CN Railbed Culvert (May 2024)

Recently, images at low tide taken by Ryan Dunphy provide a clear understanding of the discharge structure. Referring to Figure 2, taken May 2024, we now understand the inlet consists of what appears to be a multiplate arch on concrete foundations. This was likely installed inside the original stone masonry arch and extends upstream where it is covered with loose stones. We expect the upstream inlet addition was likely sealed to the original archway with pillow concrete, similar to what appears to have occurred downstream, but the area is obscured with the stones. The outlet, by contrast, appears to be a circular section with an inclined outlet that matches the railbed slope. What is disconcerting is the barrel between the inlet and outlet appears to be the original archway, with unknown dimensions, but certainly larger than the revised inlet and outlet. Hydraulically, this modification is vulnerable to blockages, and is not designed to withstand pressures that likely occurred June 2023. At the likely flow velocities in July 2023, this culvert was experiencing severe cavitation CN is lucky it was not destroyed.

Figure 2 demonstrates damage and partial reduction of hydraulic discharge capacity through blockage. The damage observed in May 2024 could have occurred during the July event or have been a pre-existing condition. The deformed CSP section is highly likely a result of cavitation during flow July 2023. As observed, the outlet culvert is deformed and is blocking drift debris from exiting the culvert. The drift debris appears firmly lodged and may have been there for some time. The culvert has diminished capacity.

Meco considered barrel blockage in our modelling but did not pursue that scenario to calibrate our hydraulic model because it was considered unlikely a corrugated culvert would block given the flow velocities. However, for the configuration present, with a different inlet and outlet design, plus a larger cavernous barrel, we can now imagine several problematic flow environments, blockage, cavitation, etc. There was almost certainly partial blockage of the outlet capacity of the culvert.

In your response to the MEH, you indicate the culvert at Barney's Brook is sized appropriately and performing as required. The image in Figure 2 indicates the outlet for the conveyance has functionally failed, is partially blocked, and if a flow event approaching a 100-year annual exceedance probability were to occur, as occurred July 11, 2024 (yesterday) in part of Nova Scotia, the railbed could collapse while the residents in the Barney Brook watershed would be exposed to life safety risk for inundation. Further, now that there is a known occurrence of pressurized flow in the culvert, the design concept of modifying the inlet and outlet for these culverts should be abandoned as inadequate, even dangerous to the public.

The images in Figure 2 are provided as a courtesy in case CN is interested in forwarding them to their maintenance group for repair works. I believe Jesse Hulsman, P.Eng. of the Municipality of East Hants has already forwarded these to CN. I am also referencing an asset assessments of the CN culverts from prior to the July storm event that may or may not have been addressed. I personally have not inspected the culverts. The full report is available on the HEH website at <https://www.easthants.ca/wp-content/uploads/easthants-occ/agendas/42816/attachments/24981/226421-20240222-East%20Hants%20-%20Revised%20Final%20Report.pdf>.
