East Hants Servicing Capacity Study

Technical Memorandum #1: Sanitary Sewer Pump Stations Assessment & Conditions Summary

RVA 226421 January 12, 2023

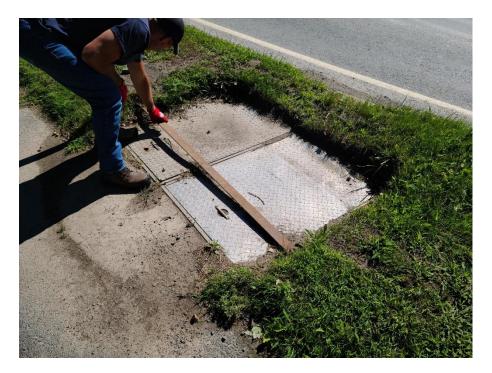
Overall, the station is in good condition. The wet-well chamber is built in the boulevard between the road and the sidewalk. The hatch cover is difficult to open due to damage from getting struck by plows and other vehicles. There is no safety grating installed. The inside of the wet-well is in good condition with some grease build up at the high-level surface. New floats installed. The guide rails and chains all in good condition. There was no sign of inflow and infiltration at the time of inspection. The stainless-steel panel box has no rust or damage and is in good condition. Inside of the

LS #9: Firehall - Damaged hatch cover

- Repair or replace wet-well hatch cover. If possible, relocate wet-well to inside of sidewalk.
- Repair or replace brick pedestal. Repair ventilation pipe.
- Expose valve chamber for future maintenance and studies.
- Installation of explosion proofing fittings should be considered.

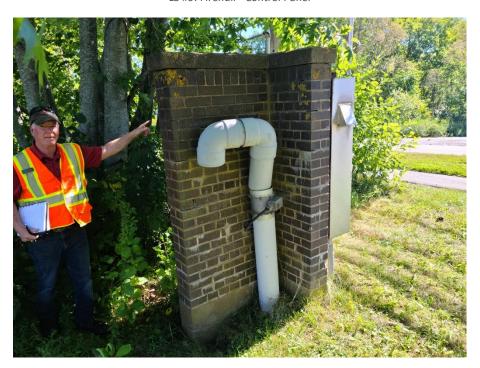
panel box has some accumulation of debris. A Surfline control panel controls the pumps for the station. The galvanized SCADA mast is secured to the utility pole. The brick pedestal has some loose bricks and is leaning to the west. The PVC ventilation pipe attached to the pedestal has the top of the gooseneck disconnected. There are no conduit seals installed on the conduit. Wet-well piping in good condition. At the time of inspection, the valve chamber was buried and unable to be inspected.

LS #9: Firehall - Pedestal in need of repair

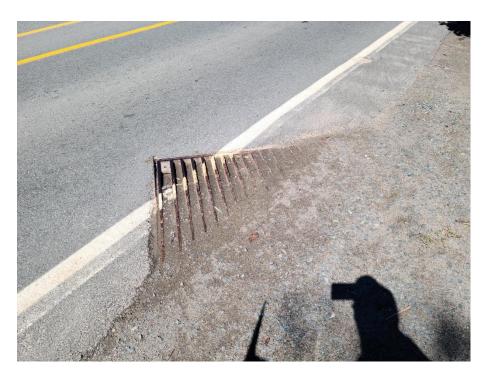
Overall, the station is in a fair condition. The wet-well access for this lift station is built into the roadway. The hatch cover for the wet-well is partially into the lane of the road and partially covered in gravel. Without traffic control and an excavator, the wet-well was unable to be accessed. The operator stated the wet-well is cleaned using a vacuum truck every 18-24 months. The valve chamber is next to the shoulder and in good condition. Due to this location, the chamber is prone to snow and run-off from the roadway. The structure of the lift station including panel box,

LS #11: Old Elmsdale School - Wet-Well hatch cover in roadway

- Installation of explosion proofing fittings should be considered.
- Relocate wet-well from lane of roadway.
- Repair brick pedestal, re-point mortar.
- Repair heat issue in panel box.
- Investigate and repair mud seeping into chamber.

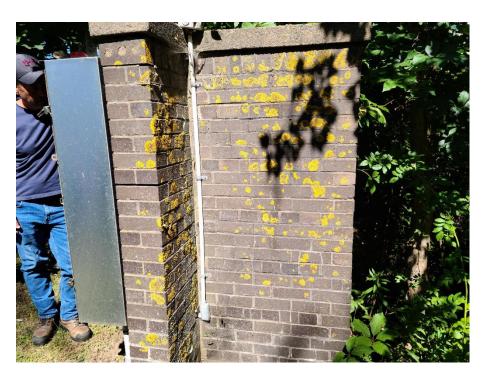
LS #11: Old Elmsdale School – Pedestal

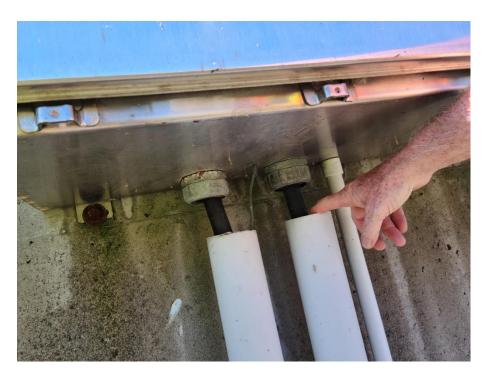
LS #11A: Industrial Park - Conduit not properly sealed

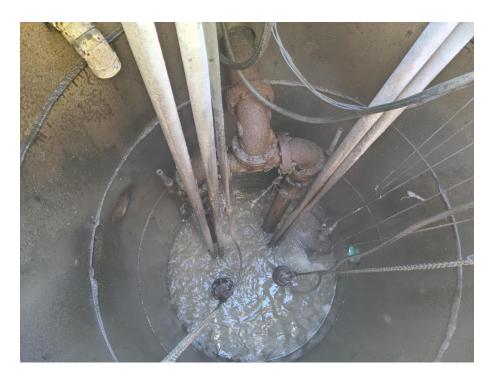
the wet-well is in good condition with no excess grease or debris build up. The guide rails, floats, and chains are all in good condition. This lift station tends to see higher flow rates due to the nearby brewery being tied in and the community pool drains here when undergoing a back wash. There was no sign of inflow and infiltration at the time of inspection. The stainless-steel panel box for the control panel has no rust but is dented on the outside. The power meter box is in fair condition but is rusty on the outside. The inside of both panel boxes are clean and there is no sign of any rust. A Surfline control panel controls the pumps for the station. The panel boxes are attached to a concrete pedestal. The pedestal is in good condition. The SCADA mast is attached to the nearby utility pole. There are no conduit seals installed on the conduit and there is no seal around the existing fittings. Wet-well piping in good condition however, the check valve is leaking when pumps are running. According to the operator, even with the major leak in the check valve, the lift station can still handle the heavy flow.

LS #11A: Industrial Park - Inside of wet-well. Note blowout from leaking check valve

- Investigate cause of leak in check valve.
- Investigate vibration and noise. Perform maintenance on Pump #2.
- Installation of explosion proofing fittings should be considered.
- Investigate source for water in valve chamber.
- Remove and replace styrofoam in valve chamber that is no longer attached to sidewalls.

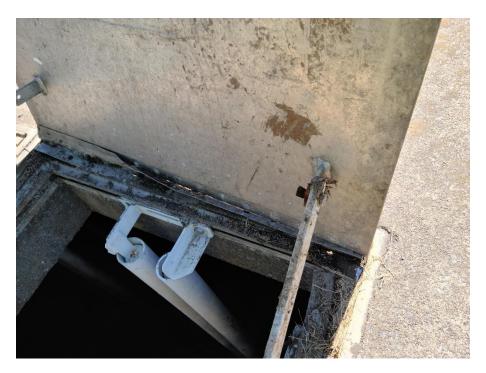
Overall, the station is in good condition. The exterior concrete of the wet-well, valve chamber, and concrete pedestal is in good condition. Attached to the concrete pedestal is the tie-in to the underground power. The conduit is not directly connected to the control panel and is prone to being vandalized. Inside of the valve chamber, the styrofoam lining is falling off with pieces of foam floating in the 600mm of water in the bottom of the chamber. The hatch cover to the wet-well is in good condition but does have a broken hinge. There is no safety grating installed. The inside of

LS #11A: Industrial Park - Broken Hinge

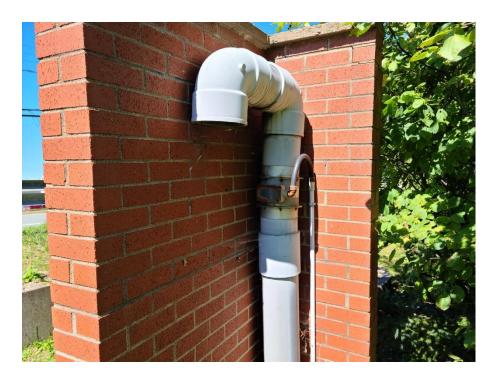
LS #12: Elmsdale Legion – Pedestal & detached ventilation pipe

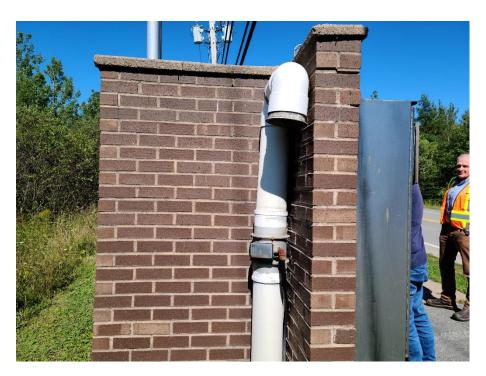
LS #14: Sportsplex - Pedestal with detached ventilation pipe

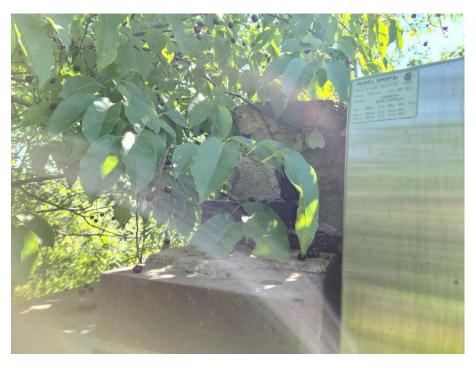
LS #16: Paley Road - Pedestal damage

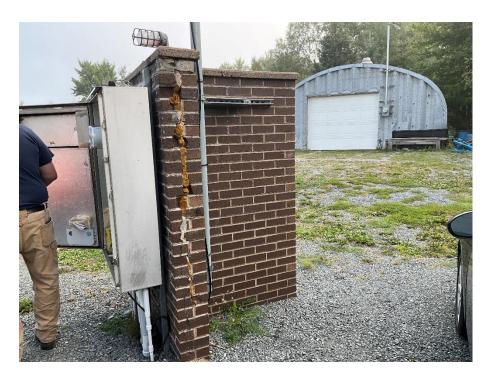
LS #17: Old Public Works Shed - Pedestal damage

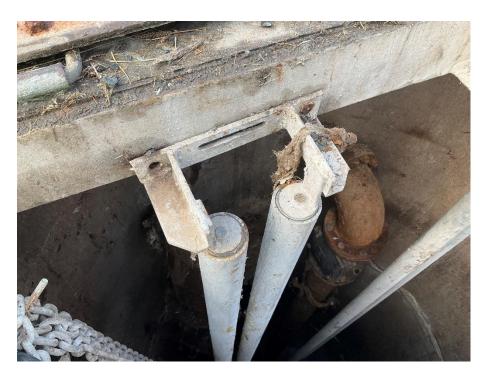
LS #18: Barney Brook - Loose guide rail bracket

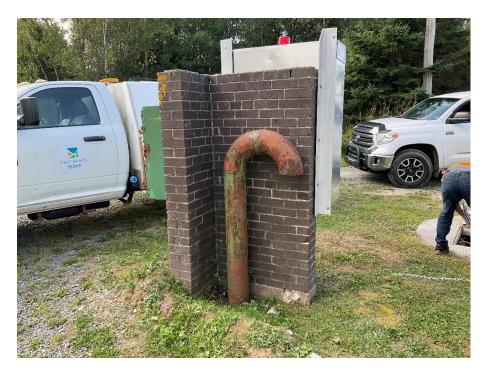
LS #18: Barney Brook - Pedestal with rusty ventialtion pipe

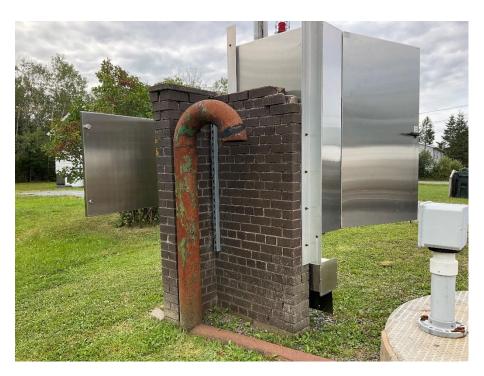
LS #20: Ross' Hill - Damaged pedestal and rusty ventilation pipe

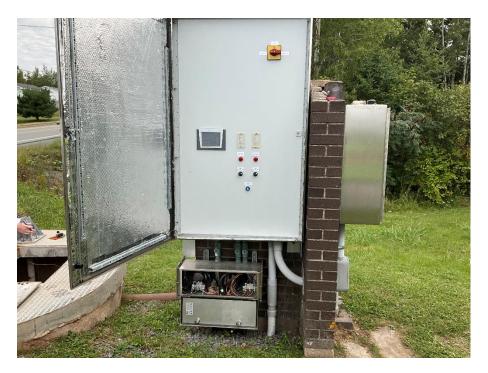
LS #20: Ross' Hill - Control Panel and unlockable electrical box

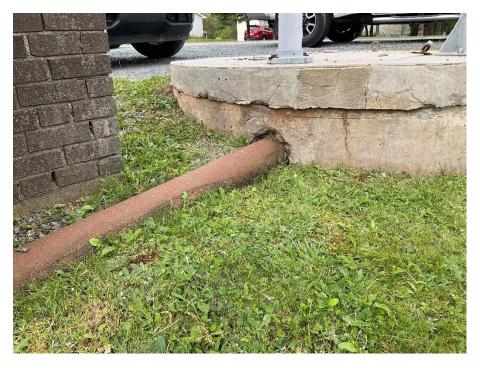
LS #20: Ross' Hill - Concrete eroded from around ventilation pipe

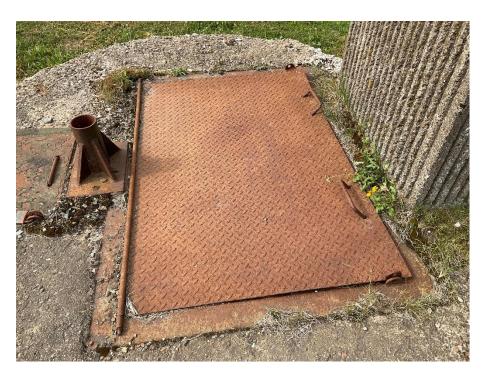
LS #21: Main Office - Rusted hatch cover
