## **East Hants – Servicing Capacity Study**

### **Technical Memorandum #6 – Stormwater Culverts Assessment Draft**

**RVA 226421**

**May 5, 2023**

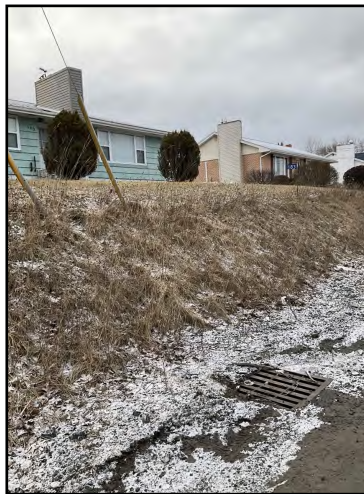
Photo 2: Catch basin on East side of shown under embankment at Civic Address 183.

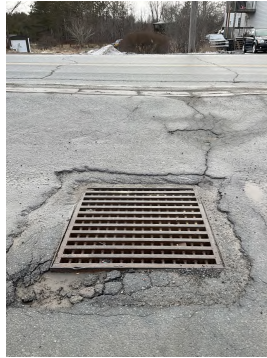
Photo 2: Catch basin connected to culvert in Post Office Parking Lot

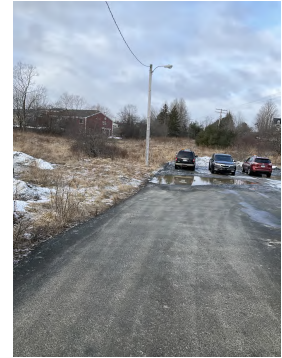
Photo 3: Rear parking lot of Post Office

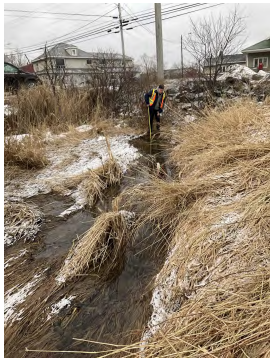
**Asset ID :** 45  
**Date of Inspection :** March 17, 2023  
**Culvert Diameter :** 600mm  
**Barrel Type/Material :** Concrete  
**Overall Condition Rating :** Fair  
**Comments :** Downstream channel filled with vegetation. Water level at obvert.  
Area behind post office flows to SE swale.

Photo 4: Downstream channel looking towards pipe

Asset ID	Issues	Recommendations
45	Downstream channel blocked with vegetation	Remove debris and vegetation from downstream channel
47	Insufficient capacity for both 5-year and 100-year storm events	Consider for replacement
48	Vegetation growth in upstream channel. Insufficient capacity for 100-year storm event	Consider for replacement
49	Debris in downstream channel	Remove debris from downstream channel
50	Debris & sediment build-up at outlet	Remove debris and sediment from outlet
52	Debris in downstream channel	Remove debris from downstream channel
54	Outlet obstructed	Remove debris from outlet
55	Debris built up downstream. Insufficient capacity for 100-year runoff event	Remove debris and consider for replacement
56	Debris build-up at outlet	Remove debris from outlet
59	Inlet blocked by haybales. Some debris downstream	Remove haybales and debris
60	Downstream headwall in need of repair	Repair headwall

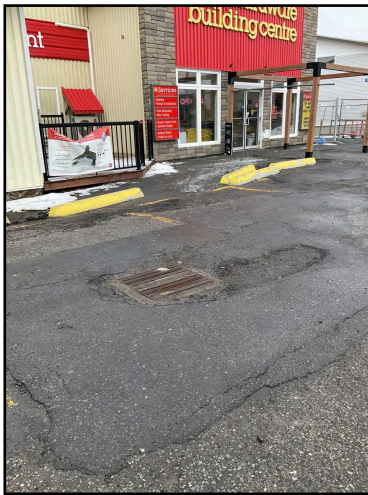
Photo 1: Catch Basin connected to culvert located in Home Hardware Parking Lot

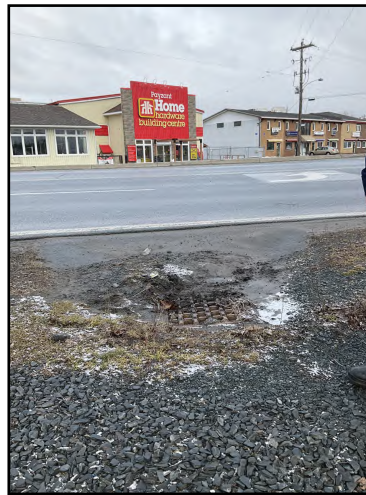
Photo 2: Catch Basin connected to culvert located across the road from Home Hardware

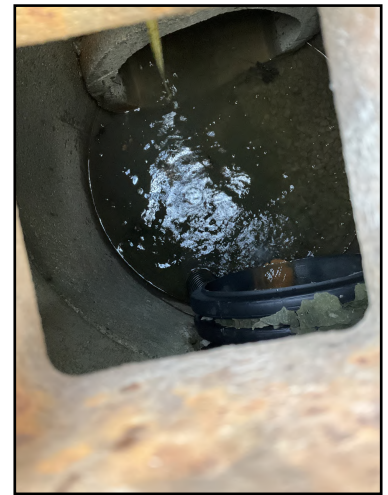
Photo 3: 600mm concrete pipe flowing NW from catch basin across the road from Home Hardware

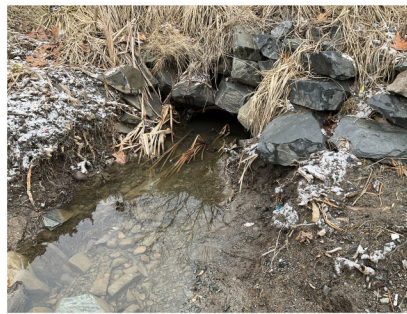
Photo 2: Outlet of culvert

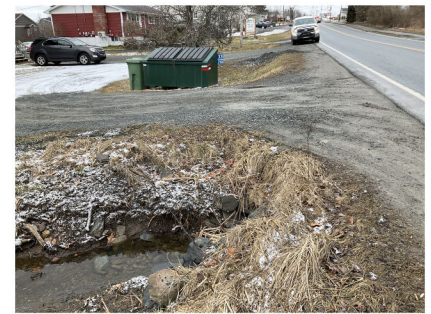
Photo 3: Ditching around outlet of culvert

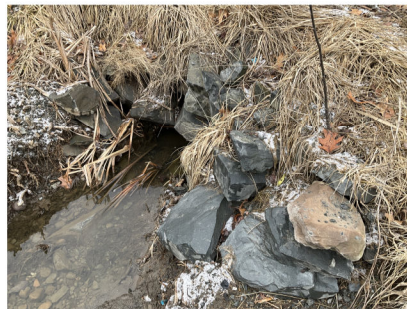
Photo 5: Outlet of culvert with approximately 180mm of water in outlet

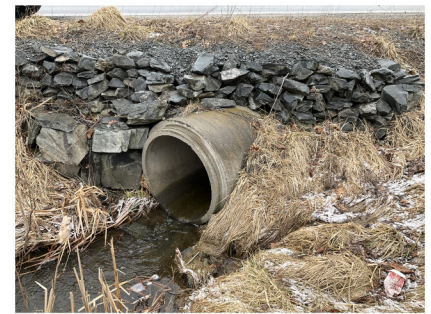
Photo 3: Outlet of pipe with restored head-wall

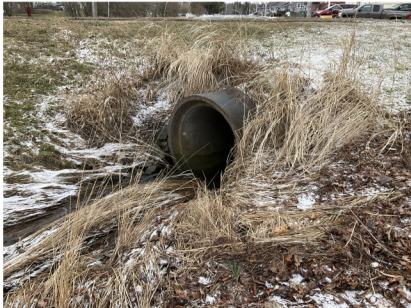
Photo 4: Inlet of culvert

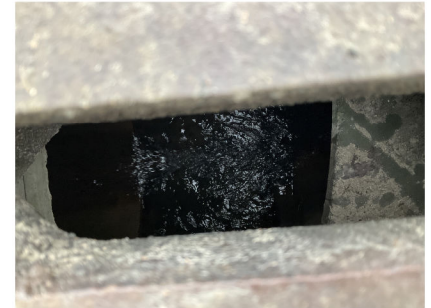
Photo 6: Catch Basin connected to culvert

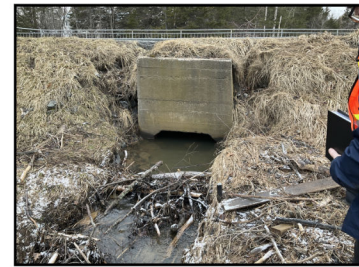
**Asset ID :** 49  
**Date of Inspection :** March 17, 2023  
**Culvert Diameter :** 1500mm US, 600 x 1300 DS  
**Barrel Type/Material :**  
**Overall Condition Rating :** Good  
**Comments :** 900mm open above debris. Downstream headwall is leaning, Upstream headwall is in good condition. Shoulder washing away above outlet of culvert. High amount of debris in downstream channel.

Photo 4: Outlet of culvert with debris buildup in channel

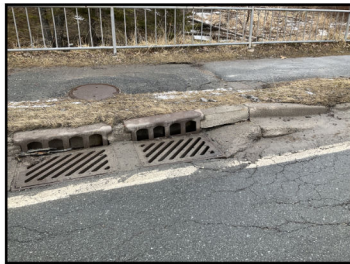
Photo 5: Storm sewer connected to culvert

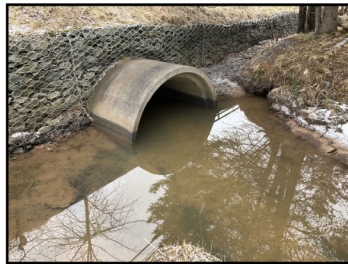
Photo 6: 1500mm concrete inlet

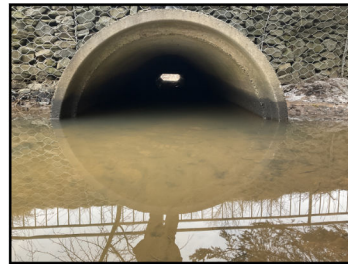
Photo 7: Inside of the culvert looking downstream

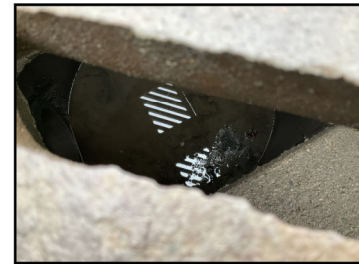
Photo 8: Inside of catch basin connected to culvert

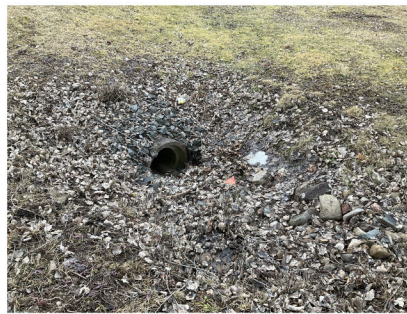
Photo 2: 400mm culvert on west side of upstream manhole

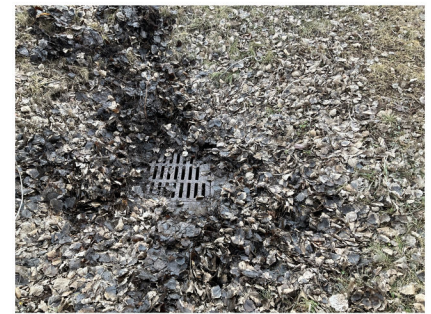
Photo 3: Catch basin on west side of culverts

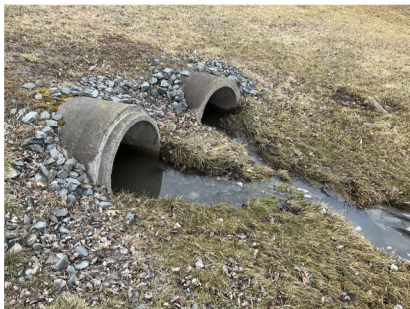
**Asset ID :** 50  
**Date of Inspection :** March 17  
**Culvert Diameter :** 900mm S, 750mm N  
**Barrel Type/Material :** Concrete  
**Overall Condition Rating :** Good  
**Comments :** Twin concrete culverts. Debris build up at outlet of both. Storm sewer on west side connected to culverts. 400mm culvert on west side of upstream manhole. No headwall. Upstream storm sewer from White Road subdivision.

Photo 4: Twin concrete culvert outlets

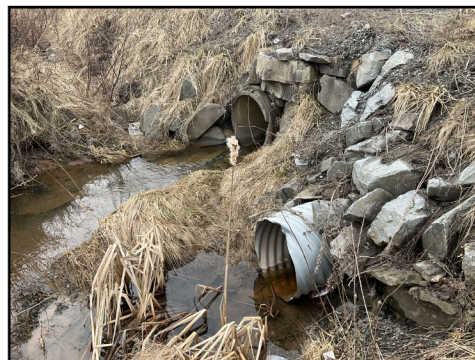
Photo 2: Outlet of concrete and steel culverts

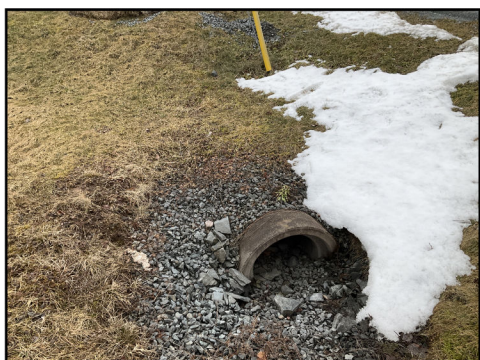
**Asset ID :** 52  
**Date of Inspection :** March 17, 2023  
**Culvert Diameter :** 750mm concrete, 600mm steel, 450mm concrete US  
**Barrel Type/Material :**  
**Overall Condition Rating :** Good  
**Comments :** Minimal high water mark on both culverts. High amount of debris in downstream channel. Gravel inside of upstream end of culvert. Storm sewer on west side connected to culverts.

Photo 3: Inlet of 450mm concrete culvert

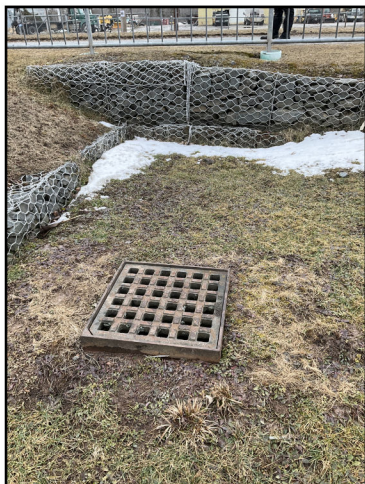
Photo 1: Upstream catch basin

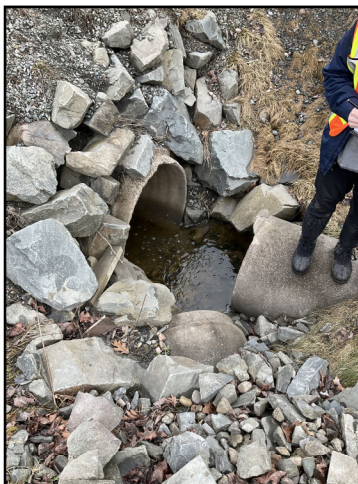
Photo 2: Outlet of pipe to pipe flowing under Truck Yard

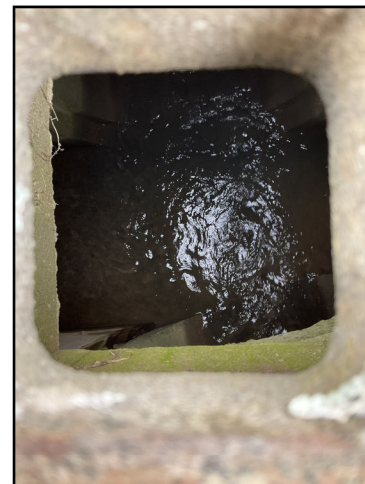
**Asset ID :** 53  
**Date of Inspection :** March 17, 2023  
**Culvert Diameter :** 900mm  
**Barrel Type/Material :** Concrete  
**Overall Condition Rating :** Very Good  
**Comments :** Upstream catch basin on top of pipe. Gabion headwall around ponding inlet. Flow passing through. Flow through 600mm culverts Downstream flows under Elmsdale Truck Yard, one heading East and one heading southeast. Storm sewer on west side of highway.

Photo 3: Inside of upstream catch basin showing flow into pipe

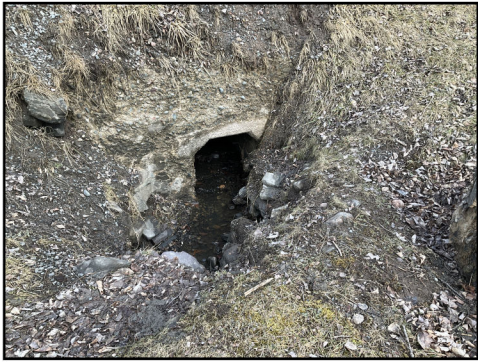
**Asset ID :** 54  
**Date of Inspection :** March 17, 2023  
**Culvert Diameter :** 900mm  
**Barrel Type/Material :** Concrete  
**Overall Condition Rating :** Good  
**Comments :** Upstream swale is grass with little obstruction. Gabion basket headwall in good condition. 600 x 600 downstream. Outlet to 450mm southeast. Vertical shoulder on top of culvert.

Photo 1: Outlet of culvert to 450mm pipe to the southeast

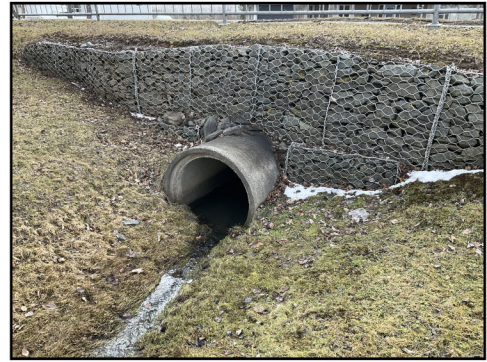
Photo 2: Inlet to culvert

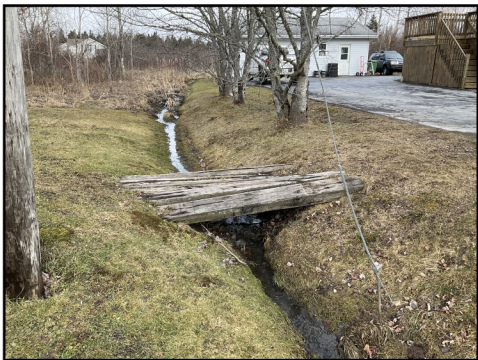
Photo 3: Grassy swale flowing into culvert

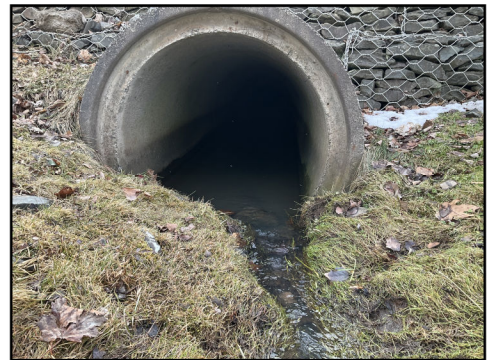
Photo 4: Inside of culvert looking downstream

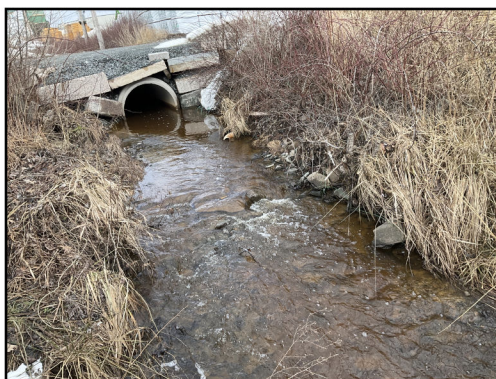
Photo 2: Upstream flow to culvert

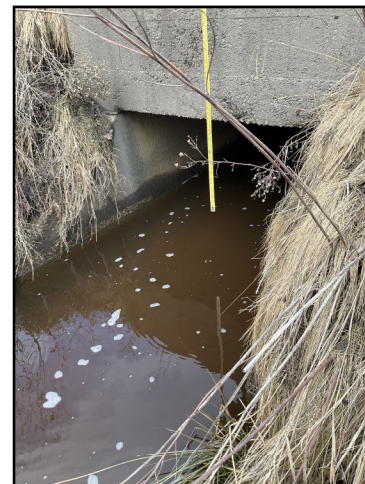
Photo 3: Outlet of culvert

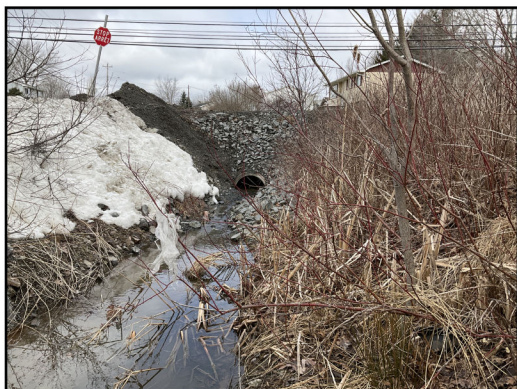
**Asset ID :** 56  
**Date of Inspection :** March 17, 2023  
**Culvert Diameter :** 770mm  
**Barrel Type/Material :** Concrete  
**Overall Condition Rating :** Very Good  
**Comments :** Brand new culvert. Stone slope along embankment to shoulder.  
Gravel deposits in downstream channel. 450mm open depth.  
Upstream channel fairly clean.

Photo 1: Flow out of outlet

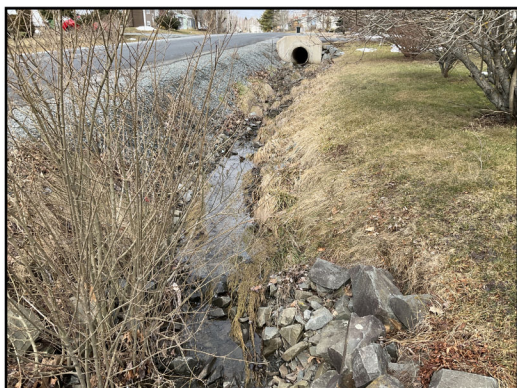
Photo 3: Drainage ditch on side road flowing to culvert

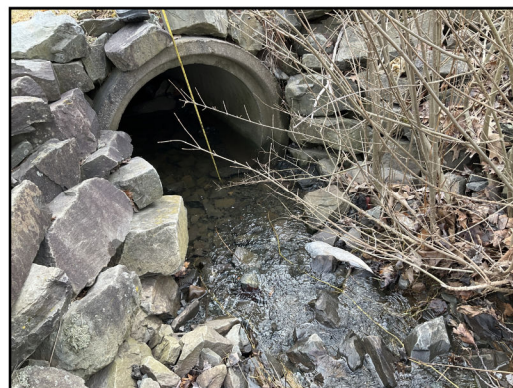
Photo 4: Inlet of culvert

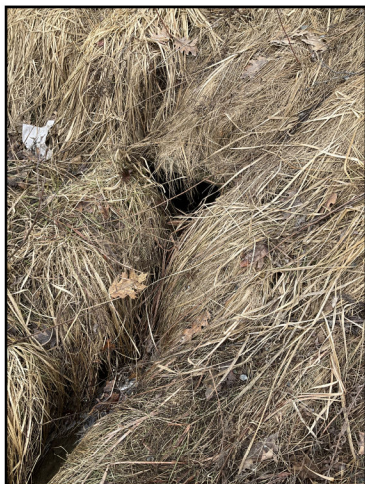
**Asset ID :** 57  
**Date of Inspection :** March 17, 2023  
**Culvert Diameter :** 600mm  
**Barrel Type/Material :** Galvanized Steel  
**Overall Condition Rating :** Good  
**Comments :** Downstream channel closed in. Shallow drainage area overgrown with vegetation. 800mm CN culvert in good condition. Upstream catch basin in good condition. Manhole above sidewalk.

Photo 1: Outlet of culvert

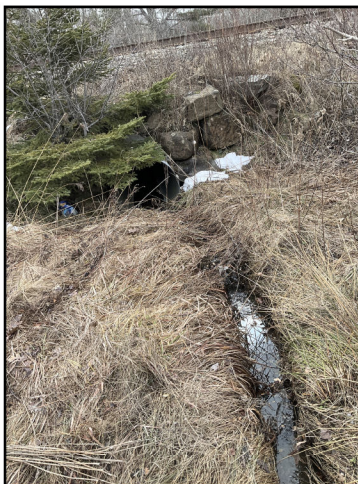
Photo 2: Downstream channel flowing to CN Culvert 13

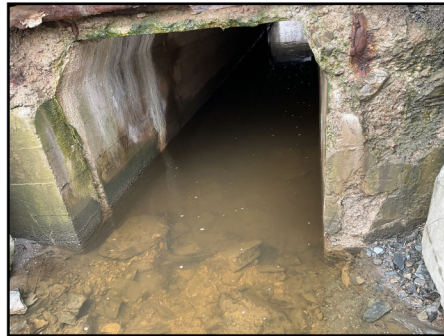
Photo 5: Outlet of culvert

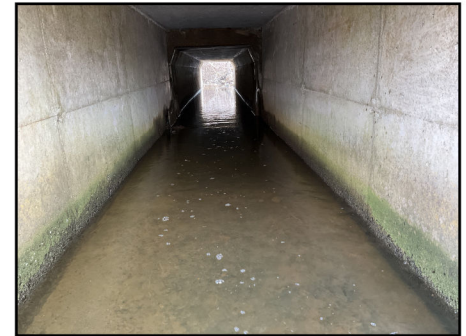
Photo 6: Inside of culvert looking downstream

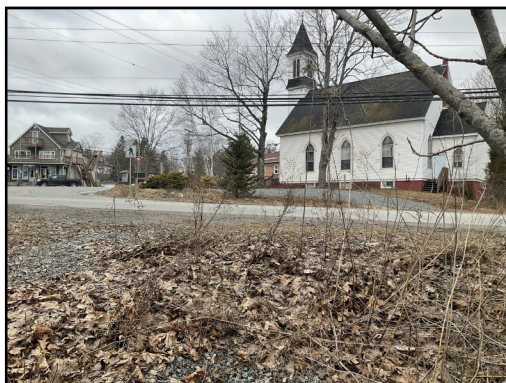
Photo 2: Looking at roadway from outlet of culvert

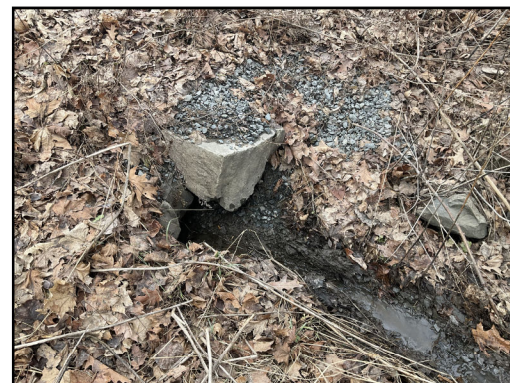
**Asset ID :** 61  
**Date of Inspection :** March 17, 2023  
**Culvert Diameter :**  
**Barrel Type/Material :**  
**Overall Condition Rating :** Fair  
**Comments :** Small culvert. Outlet between Highway 2 and railway. Pipe completely full of gravel except for top 100mm. Signs of high flow downstream. Local water moving after removing some gravel from pipe and channel.

Photo 3: Outlet of culvert

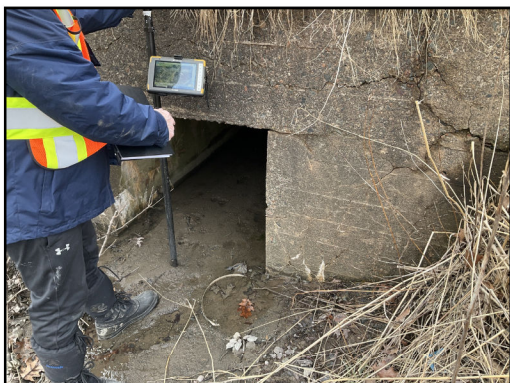
**Asset ID :** 63  
**Date of Inspection :** March 17, 2023  
**Culvert Diameter :** 900 x 750  
**Barrel Type/Material :** Concrete Box  
**Overall Condition Rating :** Good  
**Comments :** No flow, sediment on bottom of culvert. Concrete headwall with culvert structure. US pipe 450mm, connected to manhole. Big rocks inside of pipe and around pipe is blocking flow entrance. Grass buildup in channel. Storm sewer on west side with sidewalk.

Photo 1: Outlet of culvert

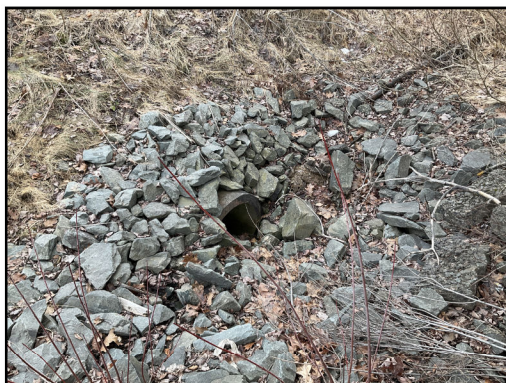
Photo 2: Inlet of culvert

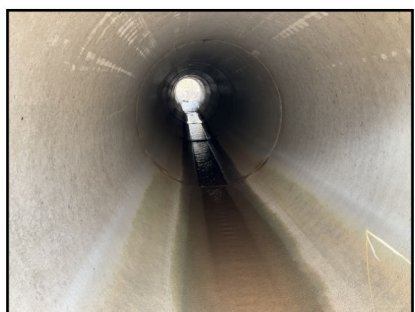
**Asset ID :** 64  
**Date of Inspection :** March 17, 2023  
**Culvert Diameter :** 1200mm  
**Barrel Type/Material :** Concrete  
**Overall Condition Rating :** Very Good  
**Comments :** Very low high water mark. Little flow. Downstream channel clear. Upstream channel clear. Rip-rap embankment on upstream and downstream.

Photo 1: Inside of culvert looking upstream

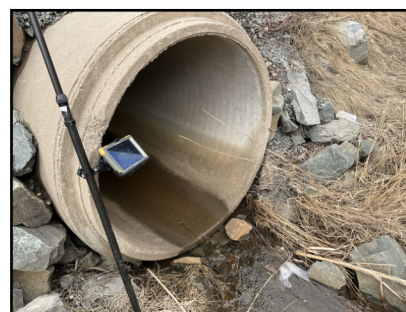
Photo 2: Outlet of culvert

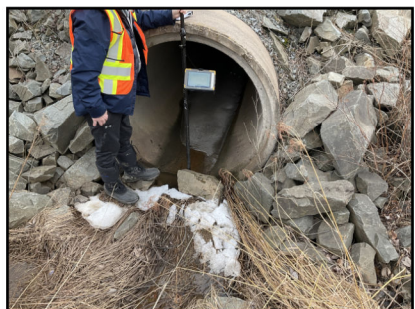
Photo 3: Inlet of culvert

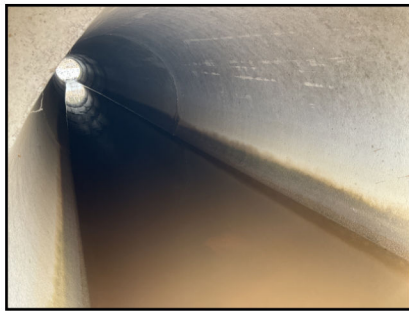
**Asset ID :** 65  
**Date of Inspection :** March 17, 2023  
**Culvert Diameter :** 1050  
**Barrel Type/Material :** Concrete  
**Overall Condition Rating :** Very Good  
**Comments :** Downstream channel is open wetland. Barrel in good condition. Upstream channel is riprap. 250mm of water in downstream end of pipe due to grass. Check dams and ditch rock lining from the south.

Photo 1: Inside of culvert looking upstream

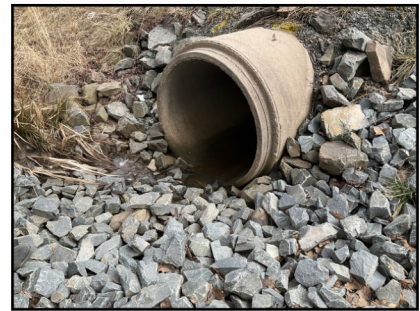
Photo 2: Inlet of culvert with rip-rap channel

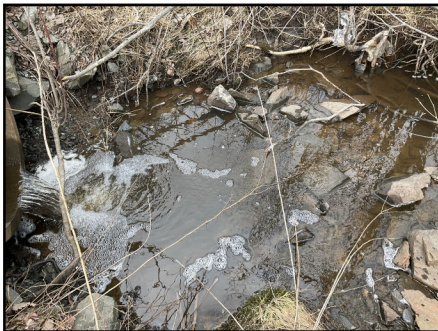
**Asset ID :** 66  
**Date of Inspection :** March 17, 2023  
**Culvert Diameter :** 900  
**Barrel Type/Material :** Concrete  
**Overall Condition Rating :** Good  
**Comments :** 600mm diameter upstream to MH, changes to 900mm out of MH. Riprap around sides and top of pipe. Downstream channel in good condition, bends to the south after discharge. 250mm drop to channel from culvert. Vegetation and rock blocking entrance.

Photo 1: Outlet area of culvert

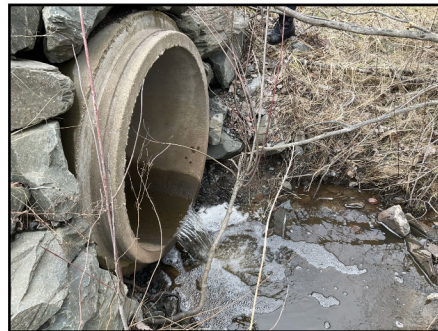
Photo 2: Outlet of culvert with rock head-wall

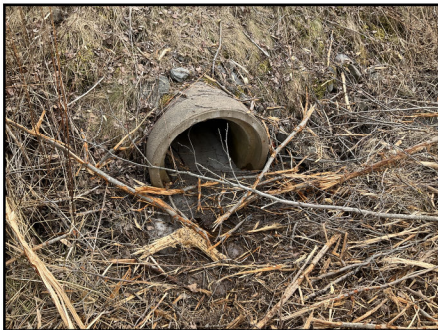
Photo 4: Debris in inlet from brush cutting operations

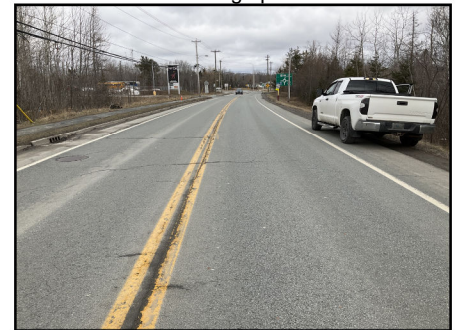
Photo 6: Road cross-section above culvert

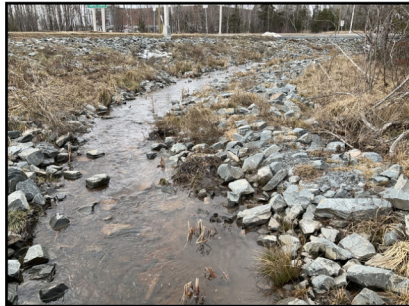
**Asset ID :** 67  
**Date of Inspection :** March 17, 2023  
**Culvert Diameter :** 750mmUS, 1200mm DS  
**Barrel Type/Material :** Concrete  
**Overall Condition Rating :** Very Good  
**Comments :** New culvert on North side of road heading southeast. 600mm open depth. Culvert realigned with roundabout along with tributary. Good flow. Downstream end grated. Wide open rip rap channel.

Photo 3: Realigned upstream tributary

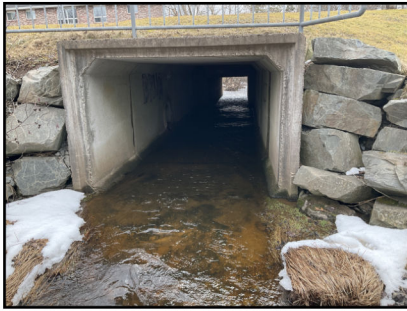
**Asset ID :** 68  
**Date of Inspection :** March 17, 2023  
**Culvert Diameter :** 1600 x 1800 DS, 2400 x 1800 US  
**Barrel Type/Material :** Concrete Box  
**Overall Condition Rating :** Very Good  
**Comments :** Strong flow. Concrete in good condition. Small drop at outlet. US channel and invert in good condition. Small drop in middle at joint.

Photo 1: Inlet to culvert

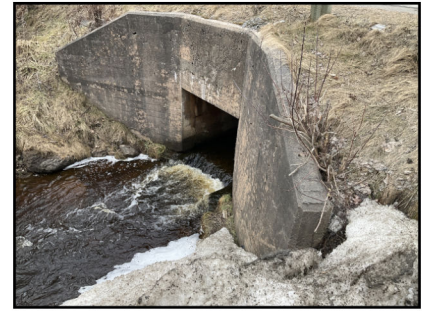
Photo 2: Outlet of culvert

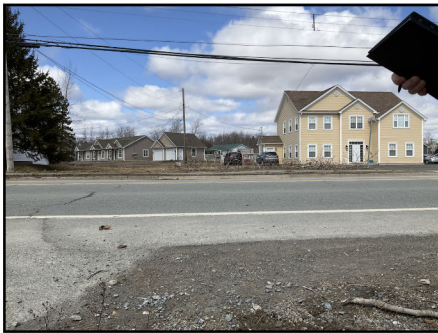
**Asset ID :** 69  
**Date of Inspection :** March 29, 2023  
**Culvert Diameter :** 750mm  
**Barrel Type/Material :** Concrete  
**Overall Condition Rating :** Good  
**Comments :** Upstream end blocked by downed tree. 300mm of bottom of culvert filled with debris, limited capacity. Good flow in downstream channel along laneway. Road above culvert has cracking. Asphalt walkway on east side.

Photo 1: View of area which flows through culvert

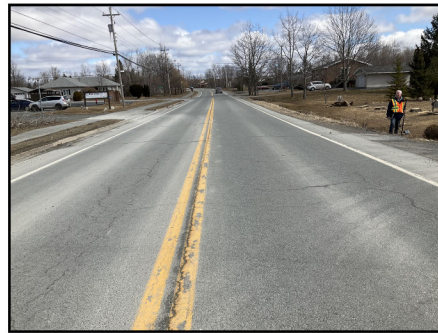
Photo 2: Road cross-section above culvert

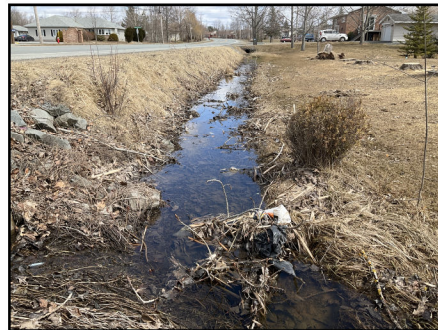
Photo 5: Downstream channel of Culvert 69A

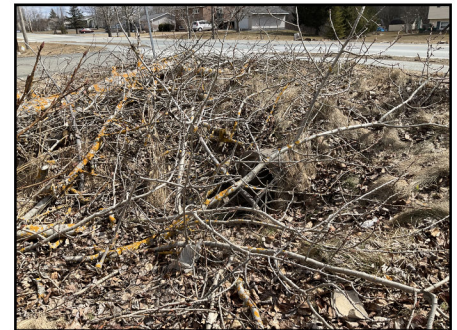
Photo 6: Tree blocking inlet

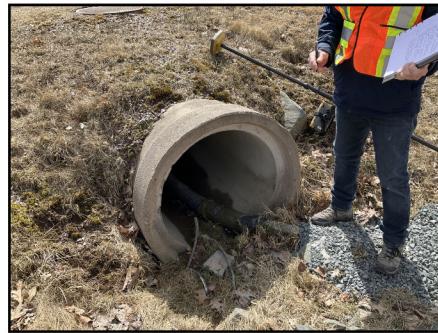
**Asset ID :** 69A  
**Date of Inspection :** March 29  
**Culvert Diameter :** 750mm  
**Barrel Type/Material :** Concrete  
**Overall Condition Rating :** Fair  
**Comments :** Local drainage from storm sewer which services daycare and Frederick Allen Drive. Perforated pipe flowing in upstream channel. Downstream channel clear with backwater observed. Pipe half full of water. Pipe collects local water from highway.

Photo 2: Inlet to culvert with perforated pipe

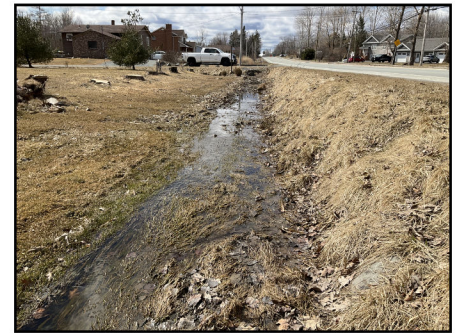
Photo 3: Downstream channel looking towards Culvert 69

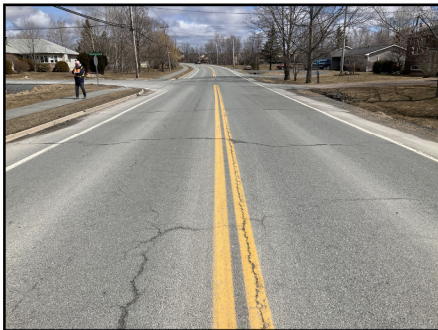
Photo 4: Road cross-section above culvert

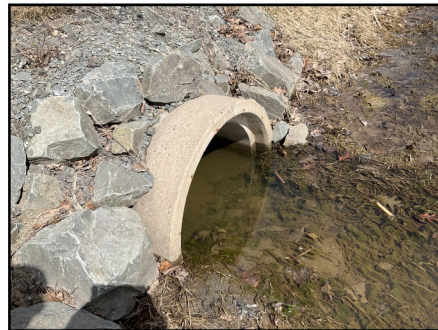
Photo 5: Outlet of culvert

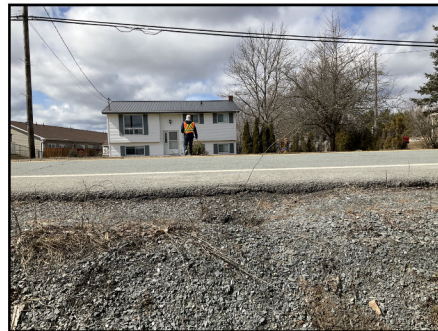
Photo 2: Shoulder of road above outlet

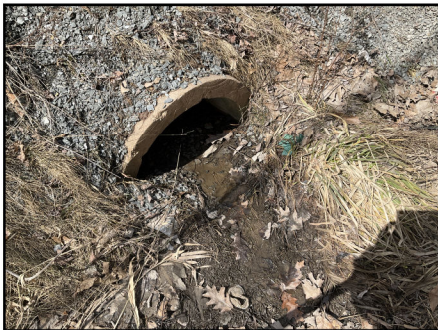
**Asset ID :** 70  
**Date of Inspection :** March 29, 2023  
**Culvert Diameter :** 600mm  
**Barrel Type/Material :** Concrete  
**Overall Condition Rating :** Fair  
**Comments :** Culvert half full of debris. Serves senior townhouse development upstream. Local ditch inlets in yards on North side. Asphalt walkway on west side with manholes. 200mm PVC pipe at west side of manhole to serve local yard. DS channel grown in with grass.

Photo 4: Outlet of culvert full half full of debris

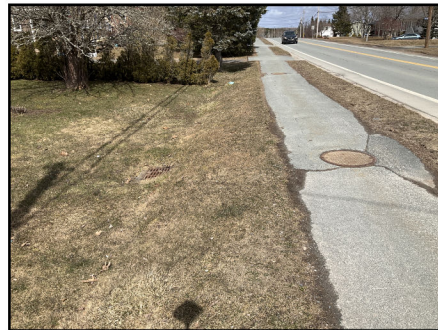
Photo 5: Catch basin in local yard upstream

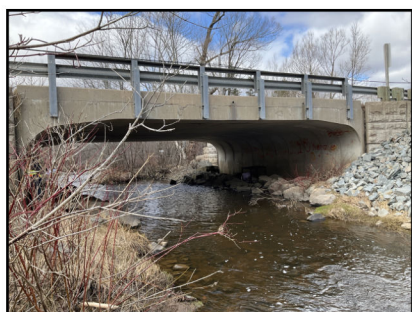
**Asset ID :** 71  
**Date of Inspection :** March 29, 2023  
**Culvert Diameter :** Conspan 2.30m vertical opening, 10m wide  
**Barrel Type/Material :** Concrete  
**Overall Condition Rating :** Very Good  
**Comments :** Conspan in very good condition, looks new. Wingwalls lined with riprap. Downstream channel drops from invert. Upstream channel drops into culvert (natural bottom). 11 pieces to culvert. High water mark 260mm above footings.

Photo 1: Conspan from downstream side

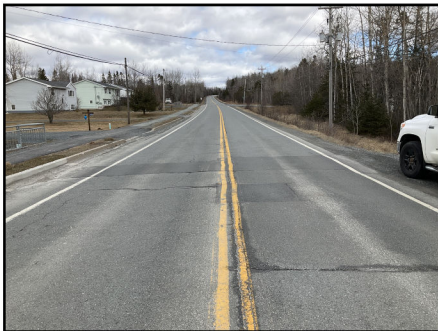
Photo 1: Road cross-section above culvert (looking Northeast)

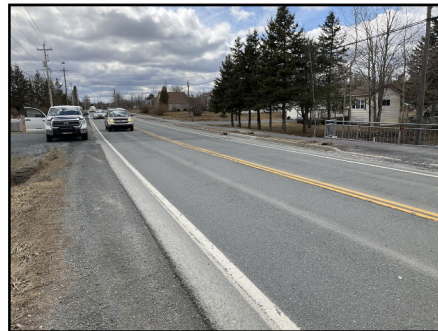
Photo 2: Road cross-section above culvert (looking Southwest)

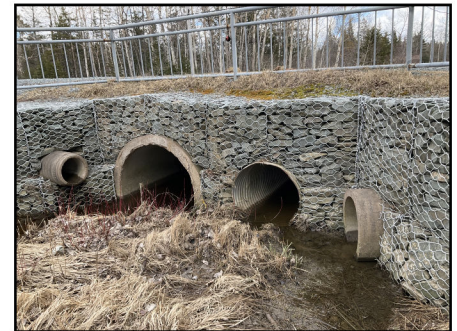
Photo 3: Inlet to culverts with new gabion basket

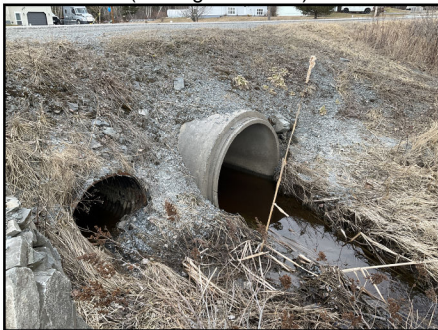
**Asset ID :** 72  
**Date of Inspection :** March 29, 2023  
**Culvert Diameter :** 1400mm  
**Barrel Type/Material :** Concrete  
**Overall Condition Rating :** Good  
**Comments :** 400mm water level. Downstream channel clean with good flow. 900mm steel culvert beside. Rusty and in poor condition. Downstream of steel culvert clogged with debris. Upstream channel flows well. New gabion head wall.

Photo 4: Outlet of culvert. Notice full flow from concrete culvert however steel culvert has debris buildup

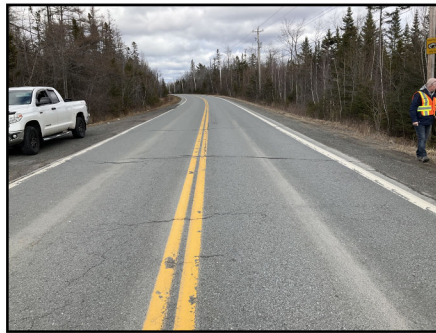
Photo 2: Road cross-section above culvert looking Northeast

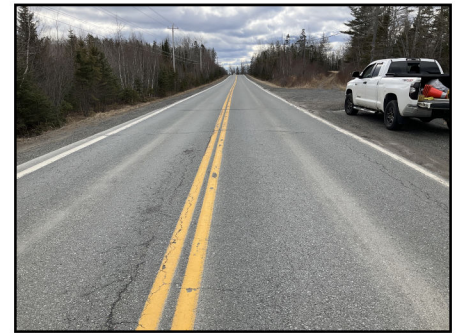
Photo 3: Road cross-section of culvert looking Southwest

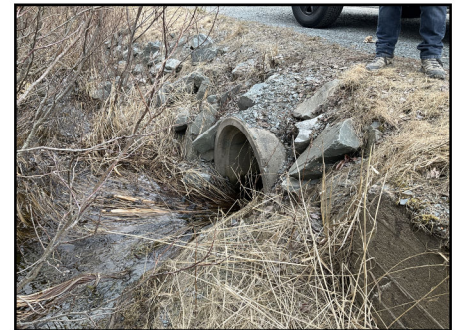
Photo 6: Inlet to culvert

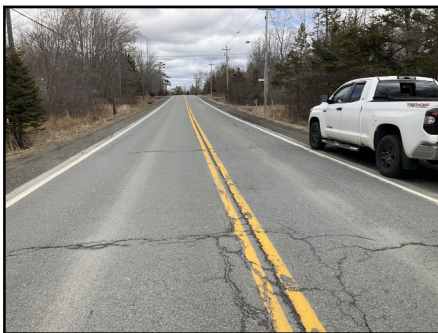
Photo 1: Cross-section of road above culvert looking Northeast

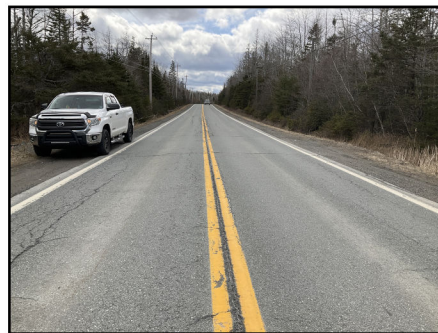
Photo 2: Cross-section of road above culvert looking Southwest

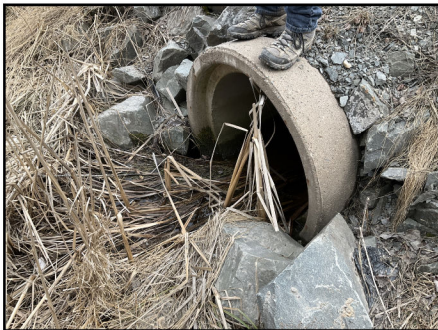
Photo 4: Inlet to culvert

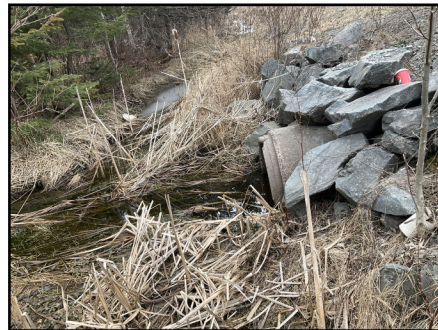
Photo 5: Outlet of culvert

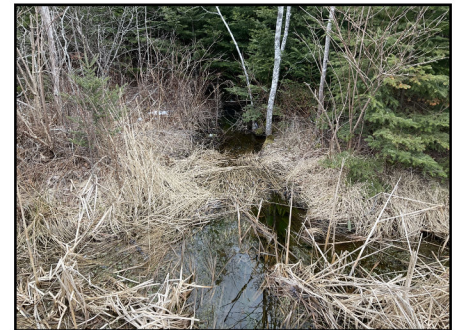
**Asset ID :** 74  
**Date of Inspection :** March 29, 2023  
**Culvert Diameter :** 750mm  
**Barrel Type/Material :** Concrete  
**Overall Condition Rating :** Good  
**Comments :** 320mm water level downstream. Upstream and downstream channels are overgrown. Local ditching on each side of culvert. At time of inspection, no development upstream.

Photo 6: Downstream culvert with vegetation obstructions

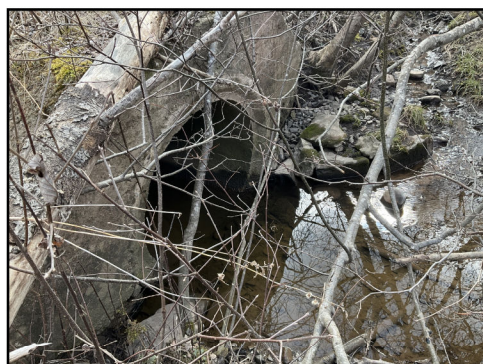
Photo 2: Inlet to culvert

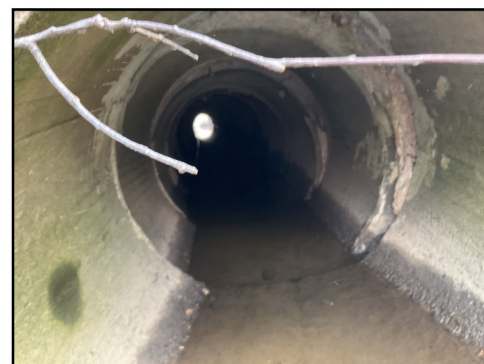
Photo 3: Inside of culvert looking downstream

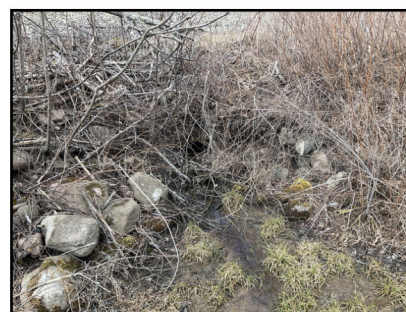
**Asset ID :** CN 23  
**Date of Inspection :** March 29, 2023  
**Culvert Diameter :** 450mm  
**Barrel Type/Material :** Galvanized Steel  
**Overall Condition Rating :** Fair  
**Comments :** Culvert is buried with little flow. 250mm of culvert is filled with gravel.

Photo 2: Downstream drainage area looking at outlet of culvert

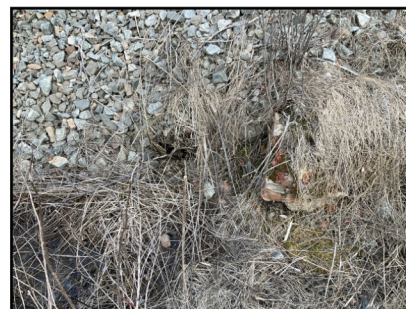
Photo 4: Inlet to culvert

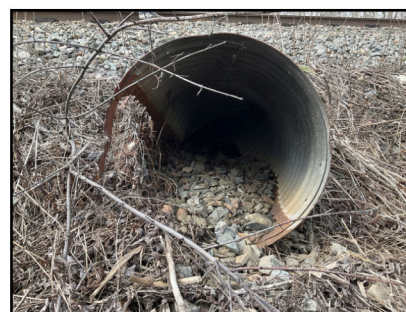
**Asset ID :** CN24  
**Date of Inspection :** March 29, 2023  
**Culvert Diameter :** 600mm  
**Barrel Type/Material :** Galvanized Steel  
**Overall Condition Rating :** Poor  
**Comments :** 200mm water level. Culvert collapsed under railway.

Photo 2: Outlet of culvert

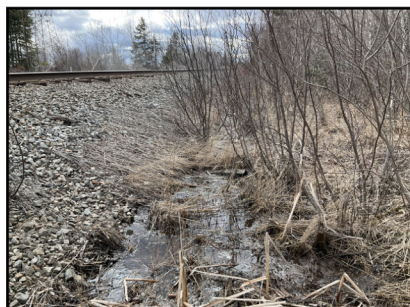
Photo 3: Area upstream of culvert along railway

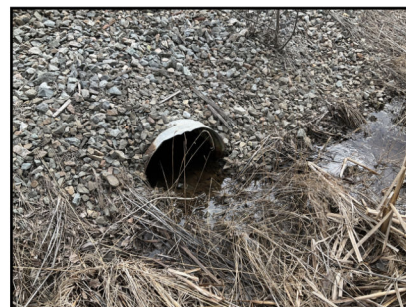
Photo 4: Inlet to culvert
