Maitland Heritage Conservation District:
Changes to the Built Environment since the creation of
the 1995 Maitland Heritage Conservation Plan & Bylaw

Bachelor of Community Design, Urban Design Thesis Project
Alyssa te Bogt
Supervisor: Kate Thompson
Dalhousie University
April 9, 2014

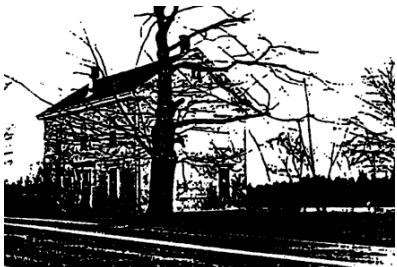
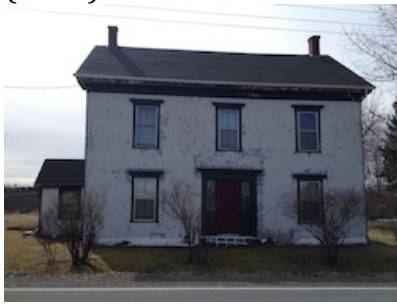
[Figure 2] Profile 1

Address:	8894 Hwy 215
In Conservation District:	No
Name:	Lockhart Lawrence House
Year of Construction:	c. 1877
House style:	Classical revival
Form:	2 storey, 3 bay façade. Symmetrical. South side of lower floor has projection with gable roof. Attic has horizontally aligned windows in gables.
Window detail:	Capped windows
Door detail:	Door is capped, and surrounded by sidelightss.
Other detail:	Friezeboard
Roof:	2 chimneys. Gable roof with returned eaves.
Photo:

Changes:	None

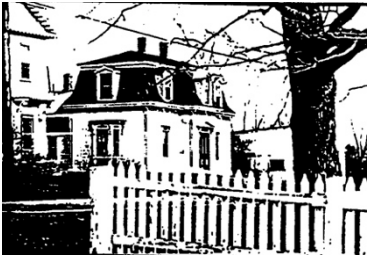
<p>(1995)</p> </div> <div style="text-align: center;">

Address:	8863 Hwy 215
In Conservation District:	Yes
Name:	Hiram Grant House
Year of Construction:	c. 1850s
House style:	Second Empire
Form:	Symmetrical, with central projecting bay. 2 storey, mansard roof, all 4 sides. 1.5 storey rear projection (original structure, older than front part of the house).
Window detail:	Central window second storey window is arched. All other windows are 2/2. Traditional bay window on one side of house. Brackets on lower floor windows. Gable dormers second floor (except for central arch window.) Decorative window caps, with wood cutout accents.
Door detail:	Front door is a double door with no windows on or surrounding. Door is bracketed and has decorative wood detail above. Arched canopy above door.
Other detail:	Decorative cornerboards and friezeboard. Contrasting paint highlights these details
Roof:	Brackets under eaves. Chimneys removed over time. Rear projection has gable roof and dormers (one shed dormer, one peaked dormer.)

Changes: Picket fence replaced with simpler fence. Chimneys removed. Paint.

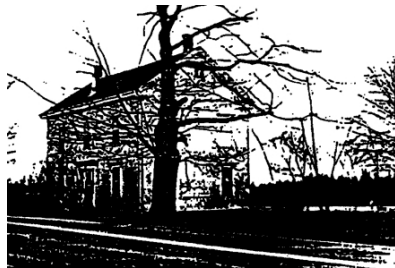
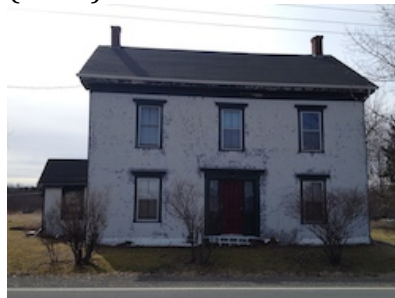
Roof: 2 chimneys. Gable roof with returned eaves.

Changes: None

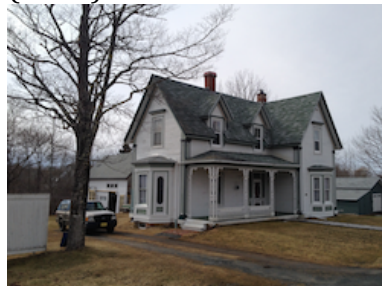
Changes: Paint

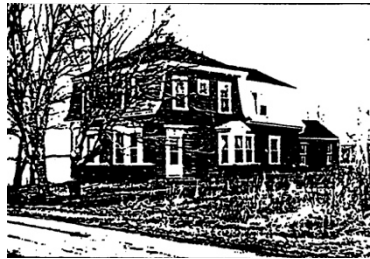
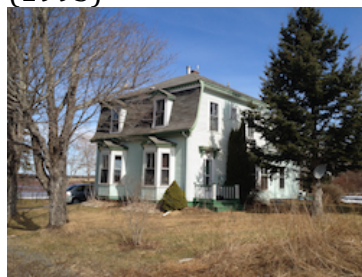
Roof: Mansard roof, central chimney.

Changes: Siding/Paint. New step by entry.

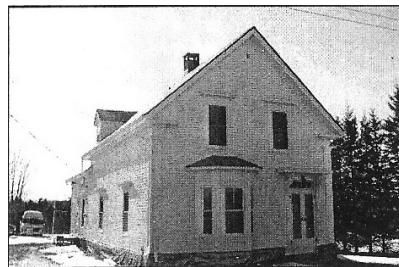
(Early 2000s)

Changes: Front step removed. Paint & shingles. Foundation work. Front door replaced.

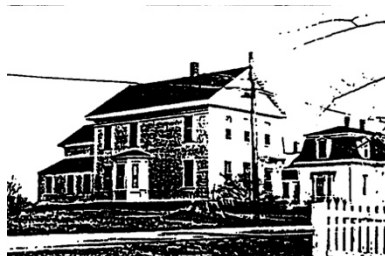
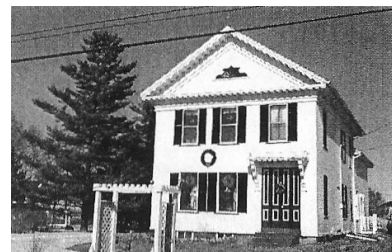
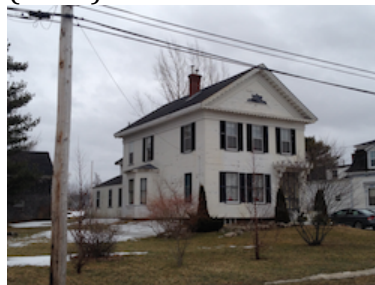
Changes: Deck built on south side of house. Upcoming exterior paint job.

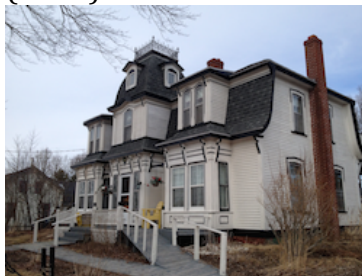
(March, 2014)

Changes: Paint, Front deck with ramp added.

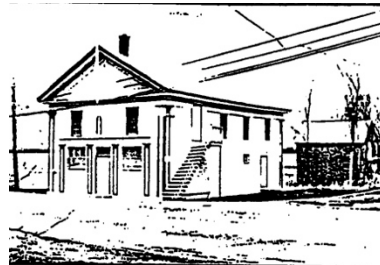
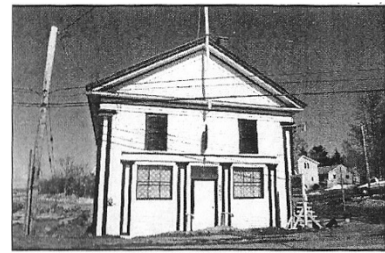
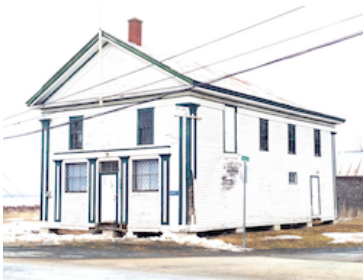
Changes: Building has had to be moved south of its original location due to sea level rise. Exterior staircase removed.

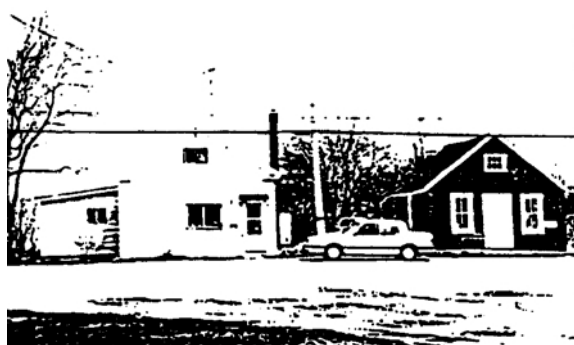
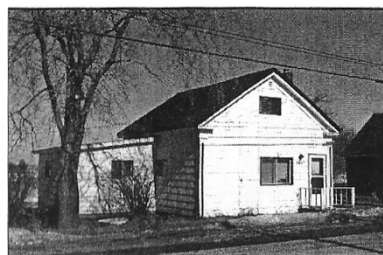
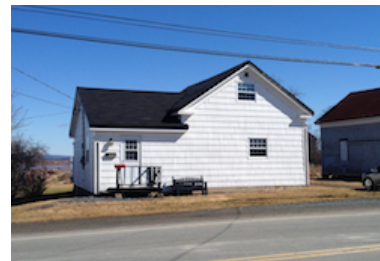
Changes: North side lean-to was demolished and rebuilt larger with a gable roof. Building to the right was torn down. Door relocated. Has new siding and paint.

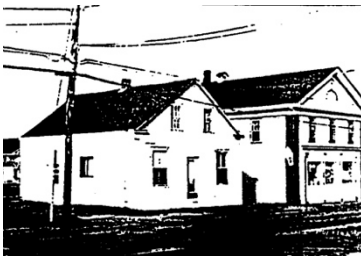
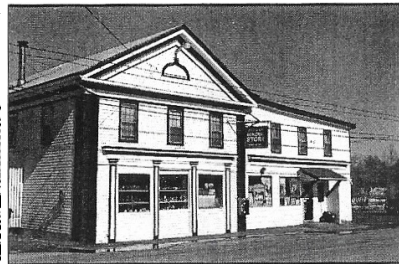
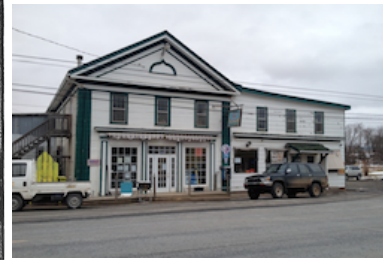
Changes: Old part of the building has had larger windows and a new door put in. New building owners are currently doing other exterior and interior renovations as well.

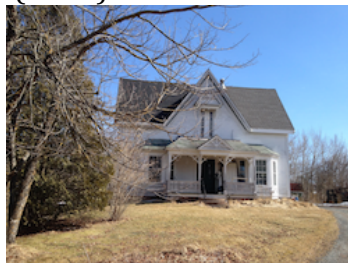
(March, 2014)

Changes: Chimney changed to metal. Paint.

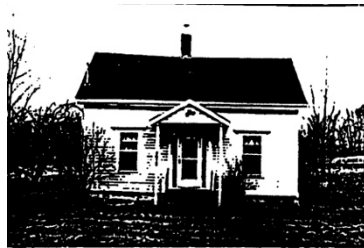
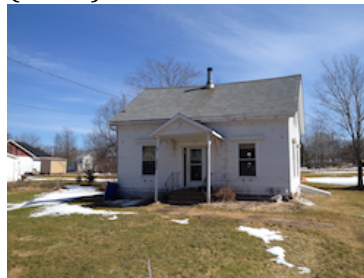
Changes: None

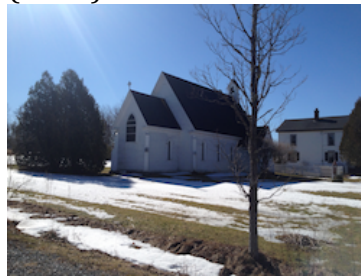
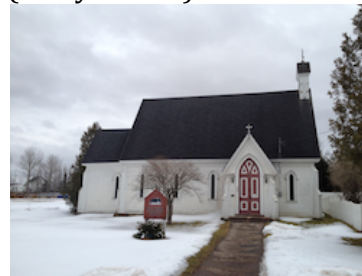
Changes: None

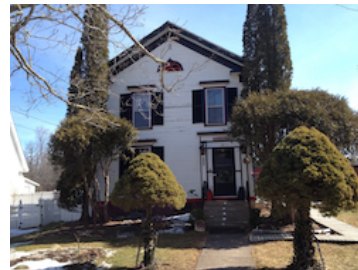
Changes: Paint

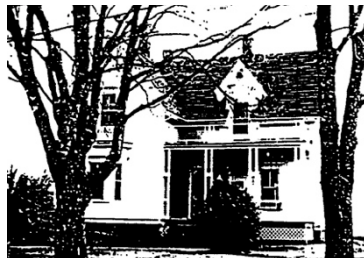
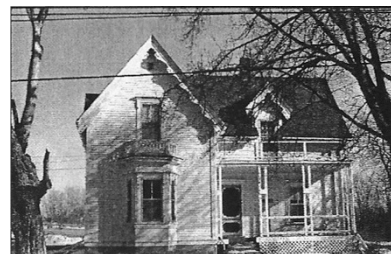
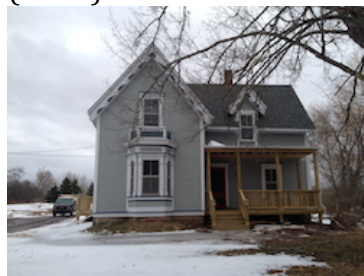
Changes: Front deck replacd, side deck constructed. Paint.

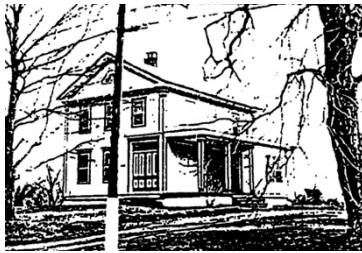
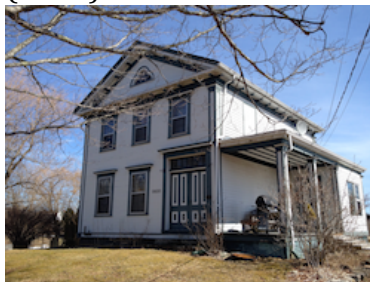
Changes: Unknown (likely paint)

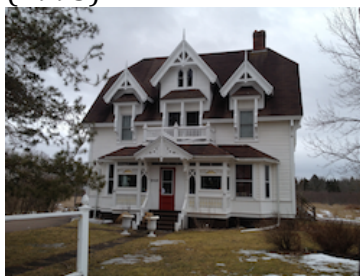
Changes: Paint. Chimney removed.

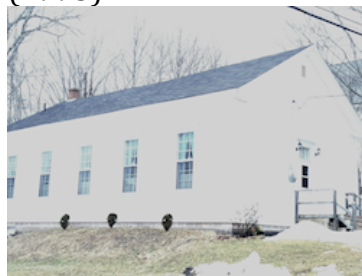
Changes: Paint.

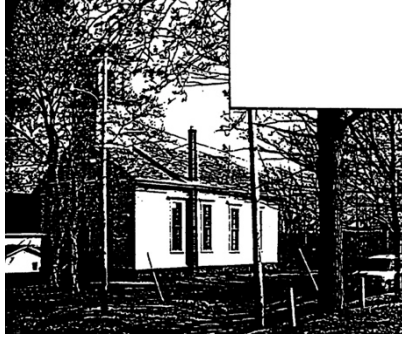
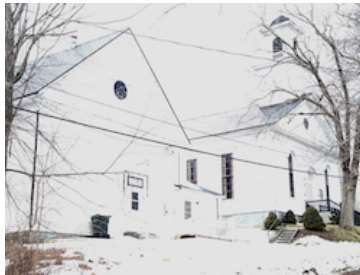
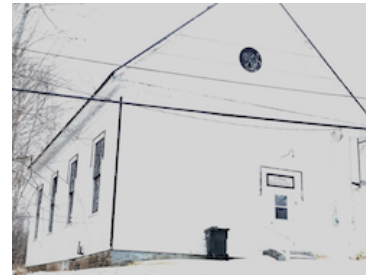
Changes: New front step with ramp on both structures.

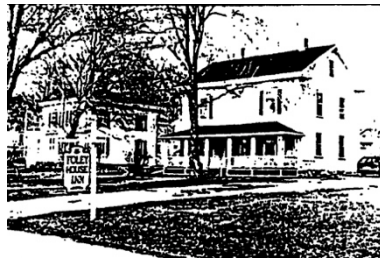
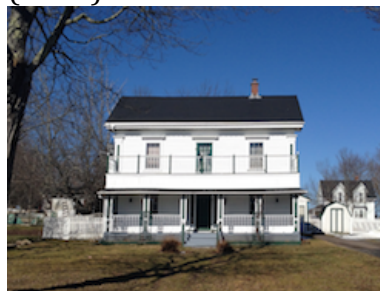
Roof: Gable roof with reverse eaves. Single chimney. Veranda once had a hipped roof, but between 1995 and 2002 this was replaced with a balcony.

Changes: Second storey veranda created, along with central door in centre of second storey. One chimney removed.

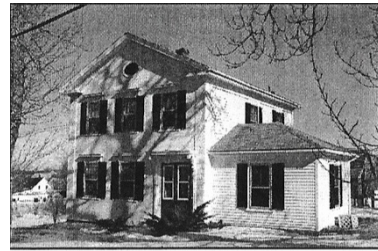
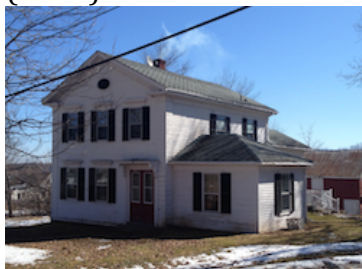
Changes: Unknown

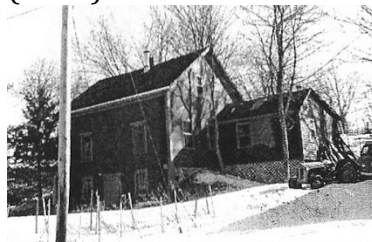
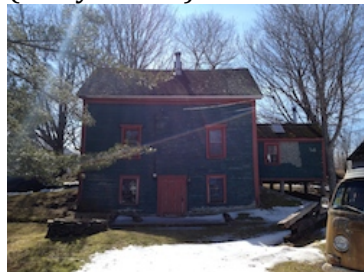
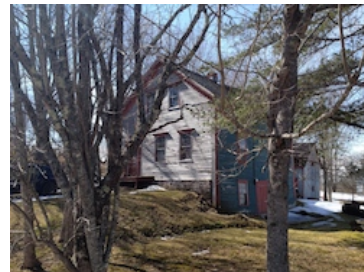
Changes: In the process of getting restored (some cosmetic changes.)

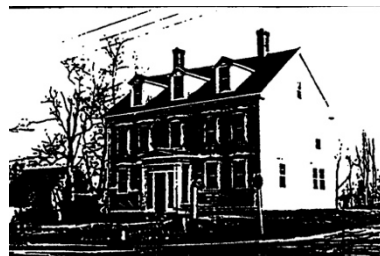
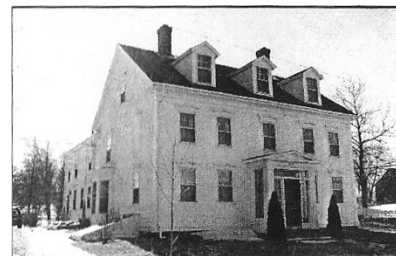
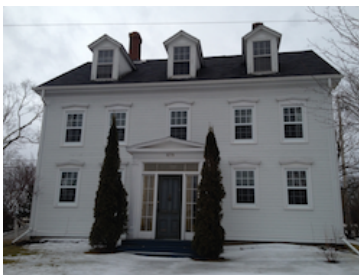
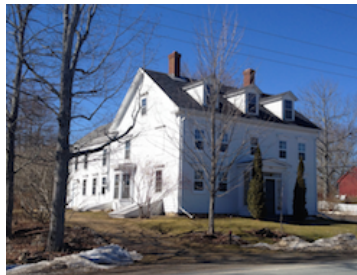
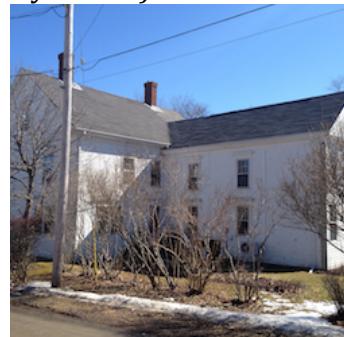
Changes: Paint.

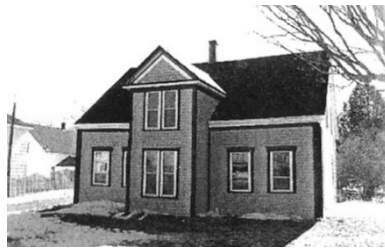
Roof: Pediment over central column. Gable roof. Central chimney.

Changes: Front central windows were replaced with a capped door with sidelights. Paint.

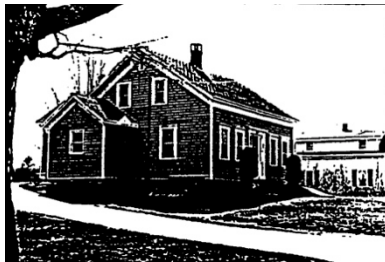
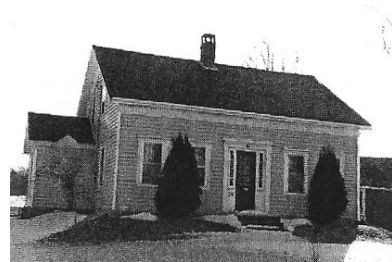
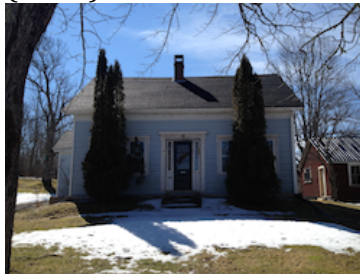
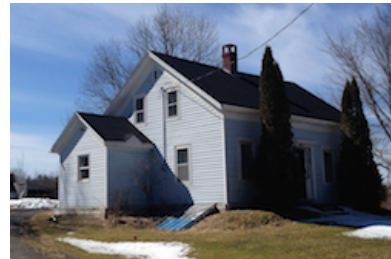
Roof: Gable roof. Central chimney. Side projection has peaked roof detail.

Changes: Paint

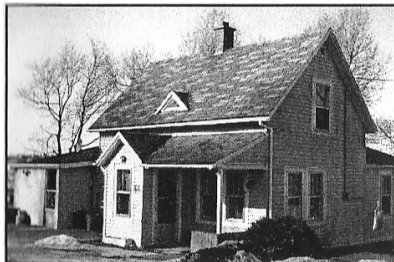
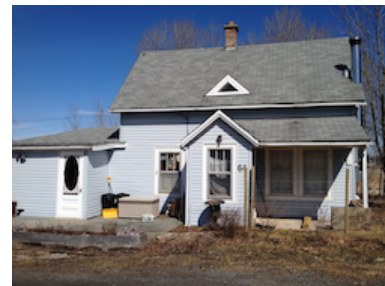
Roof: Main structure has gable roof with central chimney. Rear addition has hipped roof, side addition has a shallow hipped roof. Central triangle dormer.

Changes: Metal chimney added, possibly a new deck added as well.

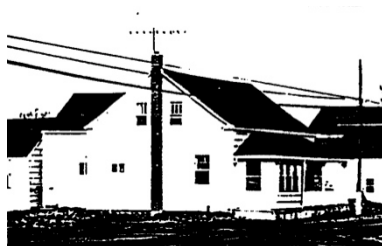
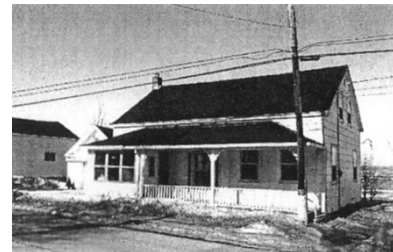
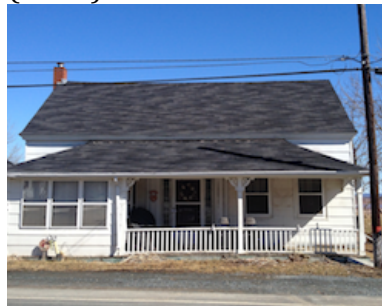
Roof: Gable roof, hipped roof veranda. Single chimney on one side.

Changes: None

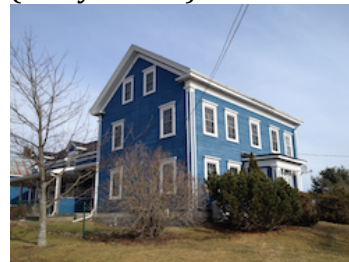
Changes: Chimneys removed

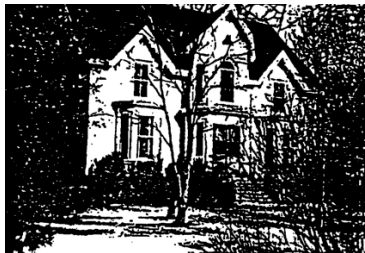
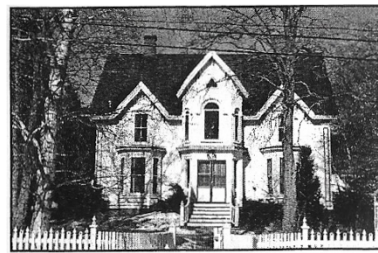
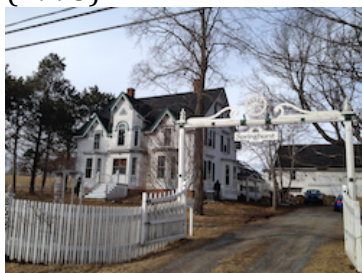
Changes: Trim has been painted.

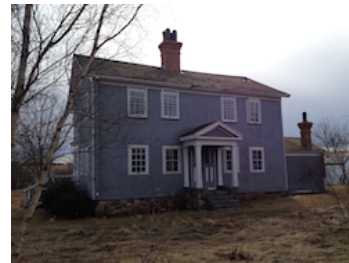
Changes: New Paint, and new exterior steps on side façade.

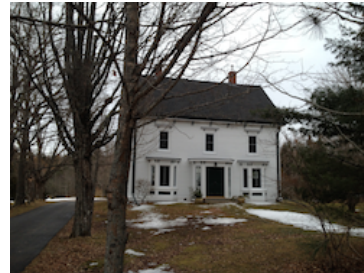
Changes: Paint.
