## **East Hants – Servicing Capacity Study**

### **Technical Memorandum #6 – Stormwater Culverts Assessment Draft**

**RVA 226421**

**May 5, 2023**

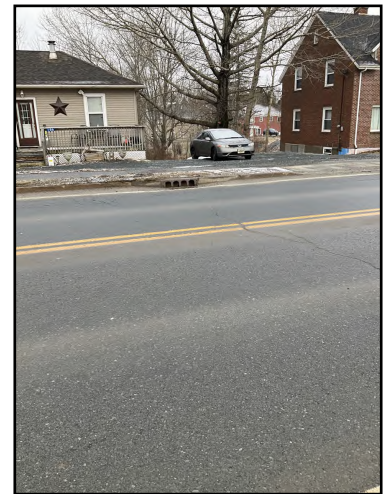
Photo 3: Storm sewer located across the road from catch basin.

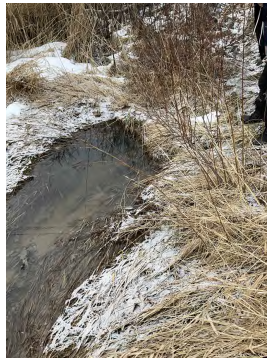
**Asset ID :** 45  
**Date of Inspection :** March 17, 2023  
**Culvert Diameter :** 600mm  
**Barrel Type/Material :** Concrete  
**Overall Condition Rating :** Fair  
**Comments :** Downstream channel filled with vegetation. Water level at obvert.  
Area behind post office flows to SE swale.

Photo 5: Outlet of pipe underwater

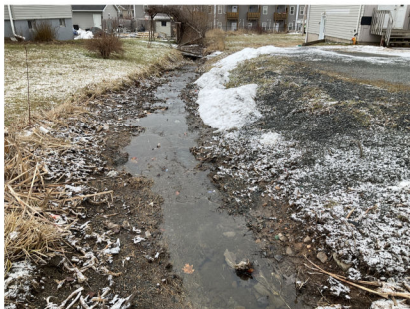
**Asset ID :** 47  
**Date of Inspection :** March 17, 2023  
**Culvert Diameter :** 600mm  
**Barrel Type/Material :** Galvanized Steel  
**Overall Condition Rating :** Very Poor  
**Comments :** Downstream channel is full of sediment. Water level 180mm below obvert. Barrel corroded. Rock headwall is falling down. Upstream manhole is in asphalt sidewalk. Catch Basin on lawn draining to culvert.

Photo 4: Downstream channel

Asset ID	Issues	Recommendations
45	Downstream channel blocked with vegetation	Remove debris and vegetation from downstream channel
47	Insufficient capacity for both 5-year and 100-year storm events	Consider for replacement
48	Vegetation growth in upstream channel. Insufficient capacity for 100-year storm event	Consider for replacement
49	Debris in downstream channel	Remove debris from downstream channel
50	Debris & sediment build-up at outlet	Remove debris and sediment from outlet
52	Debris in downstream channel	Remove debris from downstream channel
54	Outlet obstructed	Remove debris from outlet
55	Debris built up downstream. Insufficient capacity for 100-year runoff event	Remove debris and consider for replacement
56	Debris build-up at outlet	Remove debris from outlet
59	Inlet blocked by haybales. Some debris downstream	Remove haybales and debris
60	Downstream headwall in need of repair	Repair headwall

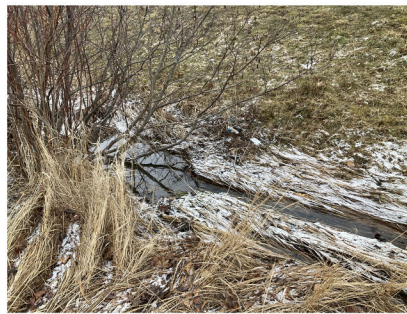
Photo 2: Vegetation growth in upstream channel

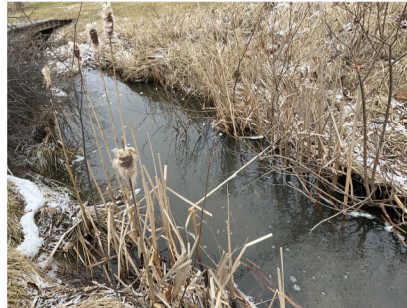
Photo 5: Downstream channel

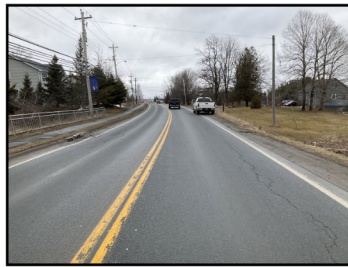
Photo 2: Cross-section of road above culvert

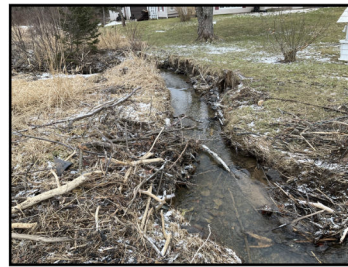
Photo 3: Downstream channel

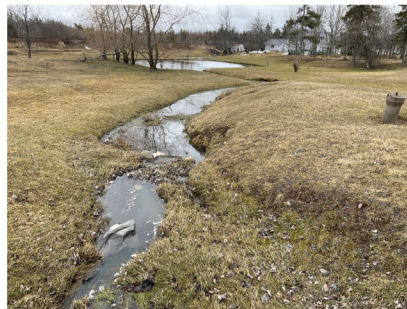
Photo 5: Downstream channel

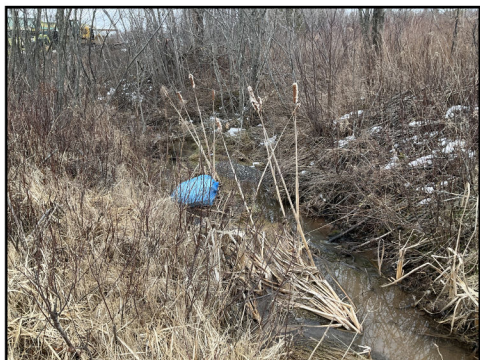
**Asset ID :** 52  
**Date of Inspection :** March 17, 2023  
**Culvert Diameter :** 750mm concrete, 600mm steel, 450mm concrete US  
**Barrel Type/Material :**  
**Overall Condition Rating :** Good  
**Comments :** Minimal high water mark on both culverts. High amount of debris in downstream channel. Gravel inside of upstream end of culvert. Storm sewer on west side connected to culverts.

Photo 1: Downstream channel

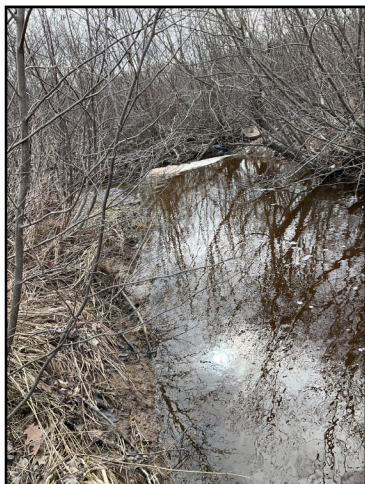
**Asset ID :** 55  
**Date of Inspection :** March 17, 2023  
**Culvert Diameter :** 1100 x 1400  
**Barrel Type/Material :** Concrete Box  
**Overall Condition Rating :** Good  
**Comments :** Vertical face downstream in good condition. Debris buildup in downstream channel. Water depth 400mm in culvert. Upstream pipe 1500 diameter. Prone to back up when river is high. Gabion basket headwall in good condition.

Photo 1: Downstream channel

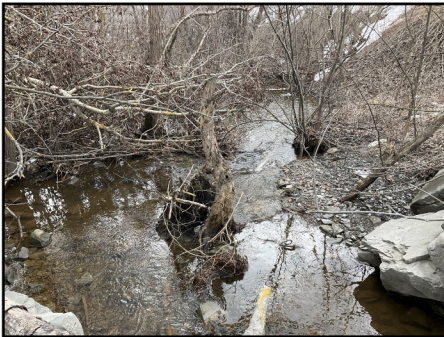
**Asset ID :** 60  
**Date of Inspection :** March 17, 2023  
**Culvert Diameter :** 1250 x 1280  
**Barrel Type/Material :** Concrete Box  
**Overall Condition Rating :** Good  
**Comments :** Culvert clean with no blockages. Upstream retaining wall leaning. Downstream headwall corroded. Wetland upstream.

Photo 1: Downstream Channel

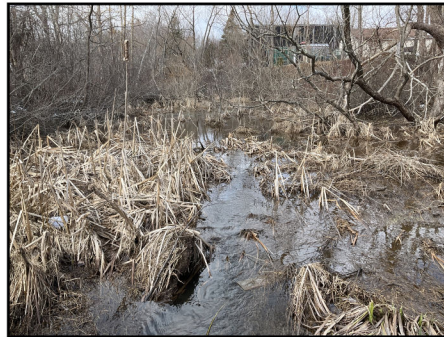
Photo 2: Vegetation in upstream channel

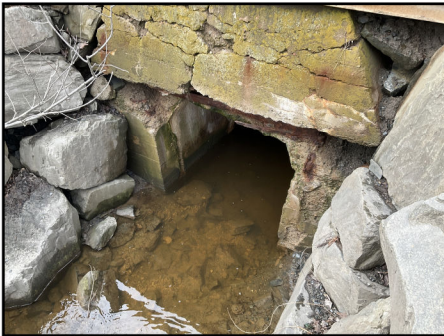
Photo 4: Downstream headwall

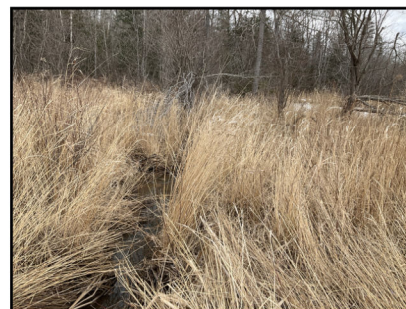
Photo 4: Downstream channel

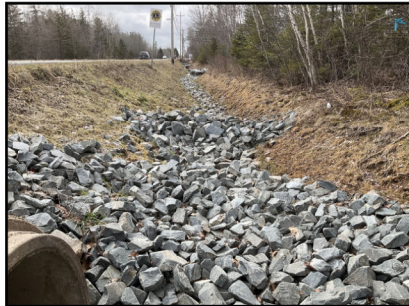
Photo 3: Upstream rip-rap channel

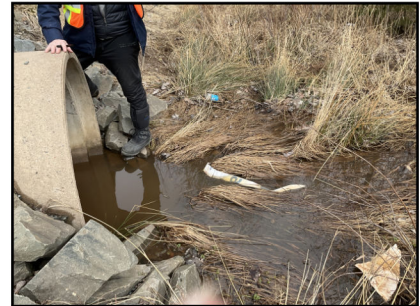
Photo 4: Downstream outlet

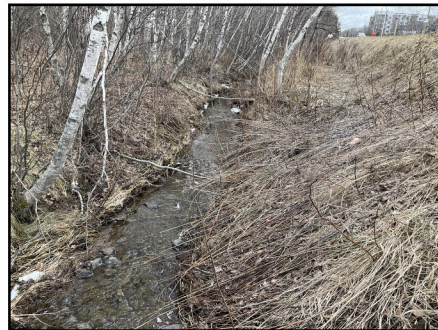
Photo 5: Downstream channel

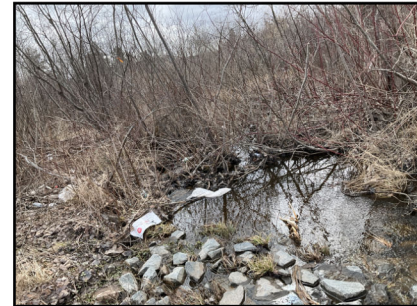
Photo 4: Downstream channel

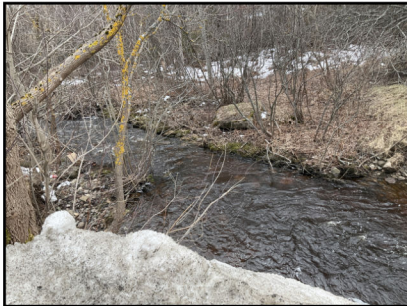
Photo 3: Downstream channel

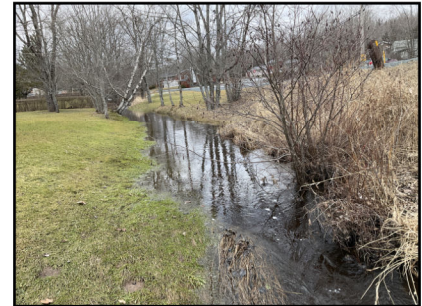
Photo 4: Upstream channel

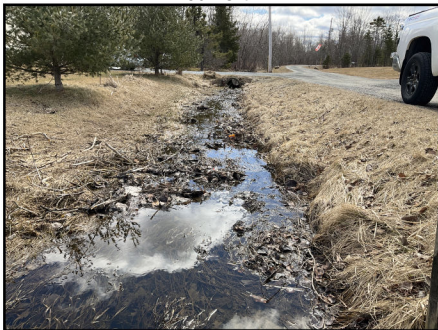
Photo 4: Downstream channel

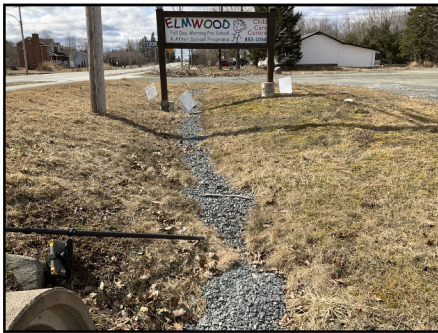
Photo 1: Upstream drainage ditch

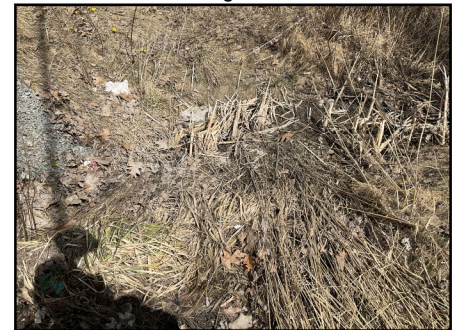
**Asset ID :** 70  
**Date of Inspection :** March 29, 2023  
**Culvert Diameter :** 600mm  
**Barrel Type/Material :** Concrete  
**Overall Condition Rating :** Fair  
**Comments :** Culvert half full of debris. Serves senior townhouse development upstream. Local ditch inlets in yards on North side. Asphalt walkway on west side with manholes. 200mm PVC pipe at west side of manhole to serve local yard. DS channel grown in with grass.

Photo 6: Downstream channel

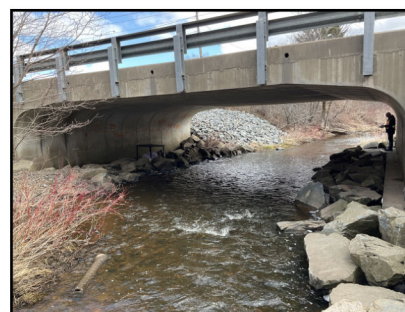
Photo 2: Conspan from upstream side

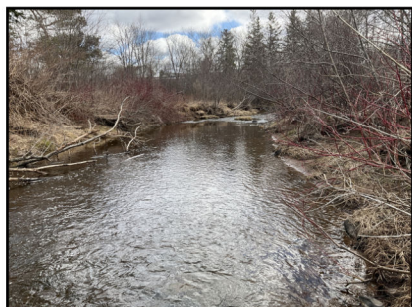
Photo 3: Downstream channel

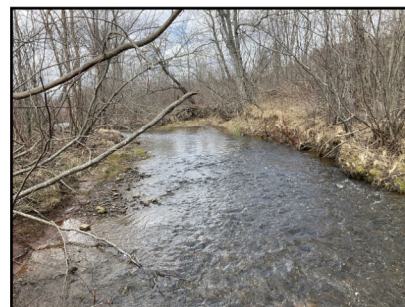
Photo 4: Upstream channel

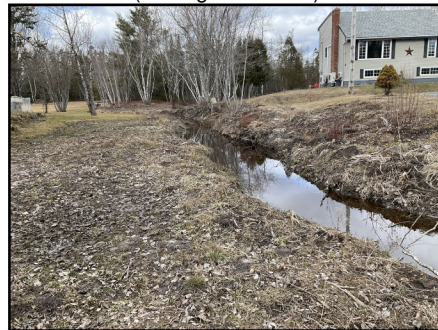
Photo 5: Upstream channel

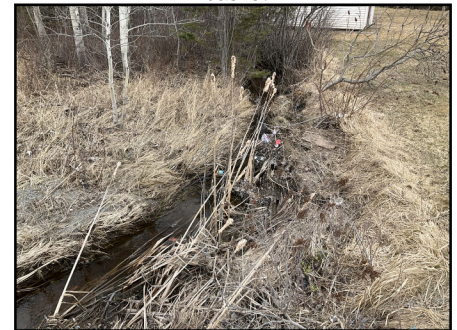
Photo 6: Downstream channel

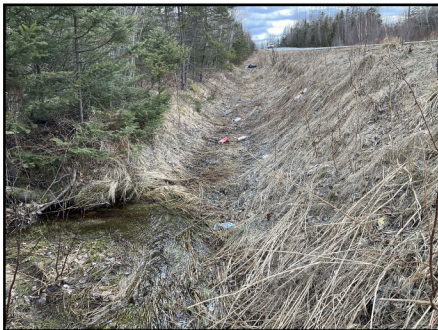
Photo 4: Downstream channel looking Southwest

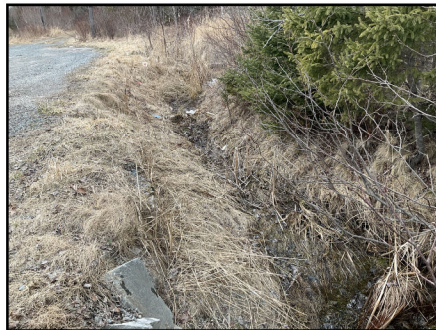
**Asset ID :** 73  
**Date of Inspection :** March 29, 2023  
**Culvert Diameter :** 750mm  
**Barrel Type/Material :** Concrete  
**Overall Condition Rating :** Good  
**Comments :** Stone installed to protect pipe on upstream side. Upstream channel grown over but flowing good with local ditching from woods. Downstream channel has little flow due to grass build up blocking channel. 100mm water depth in pipe.

Photo 5: Upstream channel looking Southwest

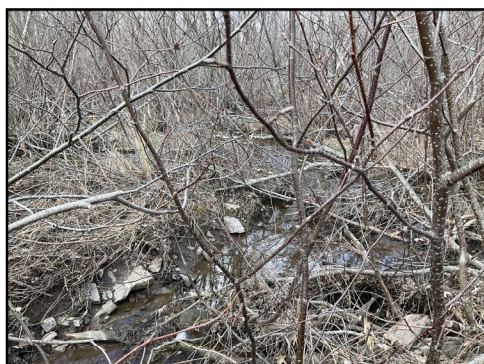
**Asset ID :** CN 22  
**Date of Inspection :** March 29, 2023  
**Culvert Diameter :** 900mm  
**Barrel Type/Material :** Concrete  
**Overall Condition Rating :** Good  
**Comments :** Good flow through upstream.

Photo 1: Upstream channel

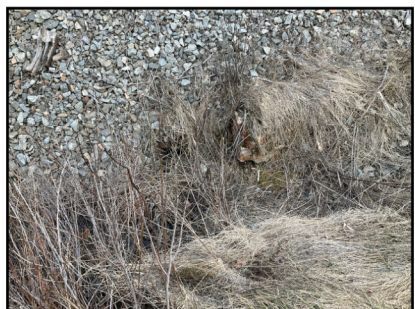
**Asset ID :** CN 23  
**Date of Inspection :** March 29, 2023  
**Culvert Diameter :** 450mm  
**Barrel Type/Material :** Galvanized Steel  
**Overall Condition Rating :** Fair  
**Comments :** Culvert is buried with little flow. 250mm of culvert is filled with gravel.

Photo 3: Upstream channel with vegetation growth
