East Hants Servicing Capacity Study

Technical Memorandum #1: Sanitary Sewer Pump Stations Assessment & Conditions Summary

RVA 226421 January 12, 2023

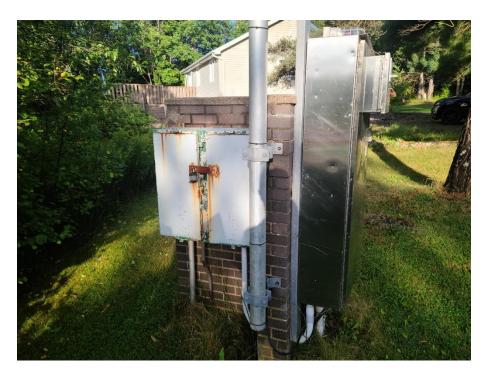
LS #1: Peter Horne Station: Pedestal & Control Panel

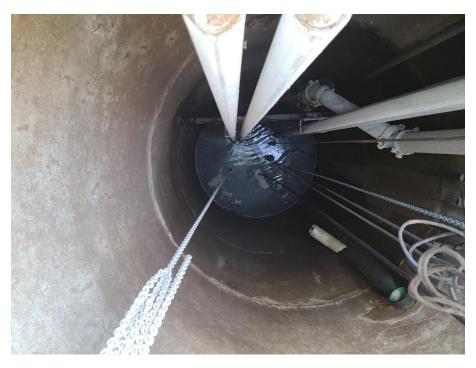
LS #1: Peter Horne Station - Inside of Wet-Well

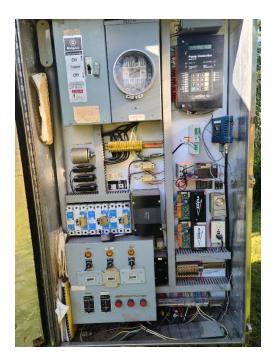
LS #1: Peter Horne Station - Inside of Control Panel

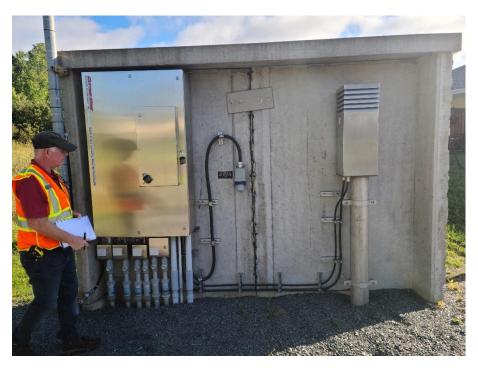
LS #2: Sherwood Park - Control Panel & Pedestal

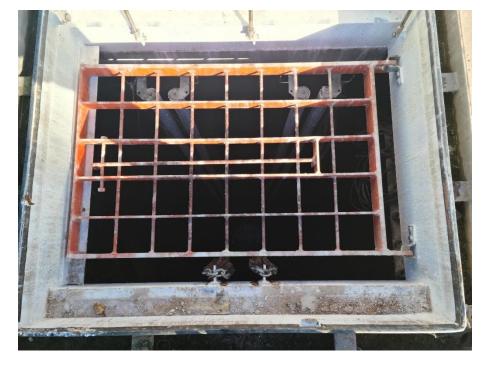
LS #2: Sherwood Park - Safety Grating

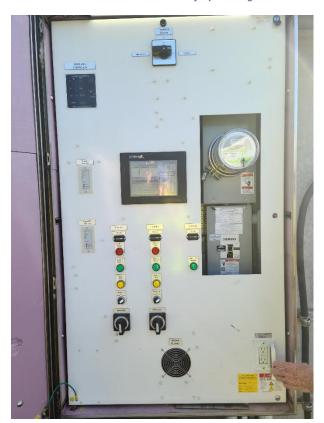
LS #2: Sherwood Park - Control Panel

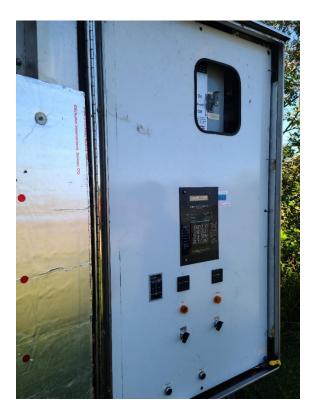
LS #3: Horne Settlement - Control Panel

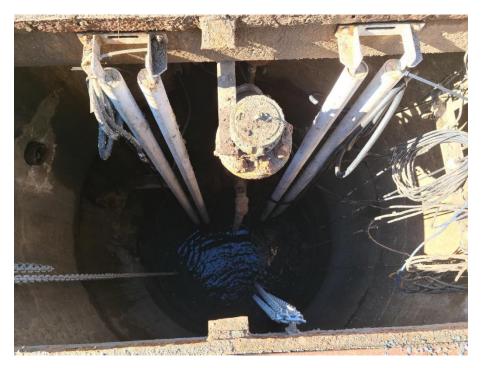
LS #3: Horne Settlement – Inside of Wet-well

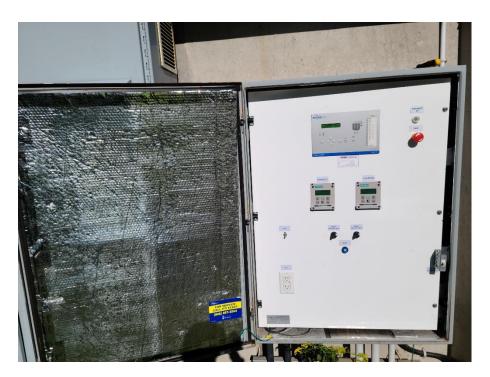
LS #4: Donaldson Ave - Control Panel

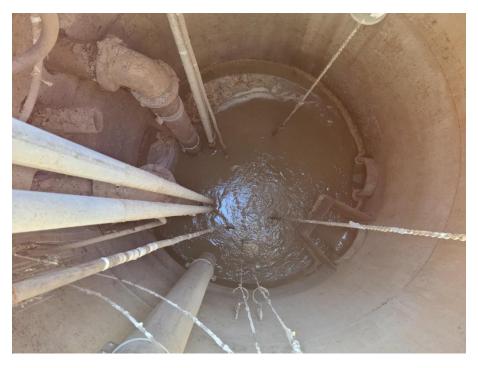
LS #4: Donaldson Ave - Inside of Wet-Well

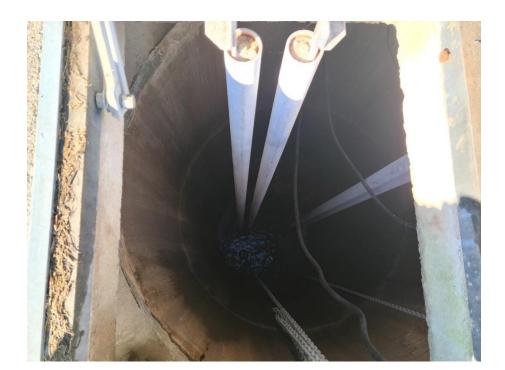
LS #5: Locks Road - Inside of Wet-Well

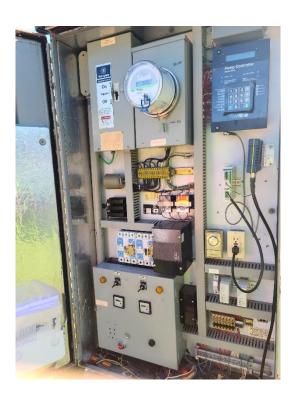
LS #5: Locks Road - Control Panel

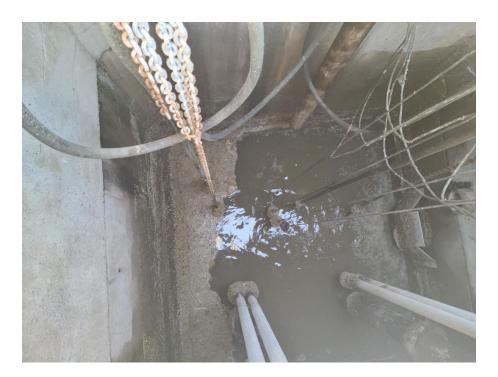
LS #7: Curley Portables - Inside of Wet-Well

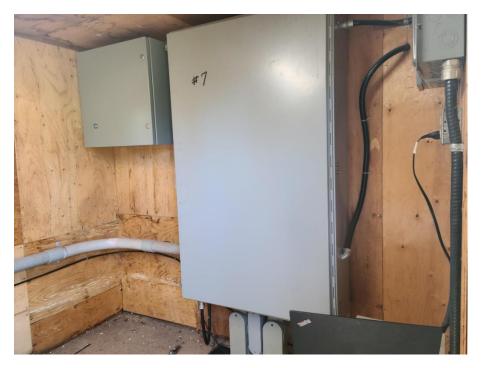
LS #7: Curley Portables - Control Panel inside of building

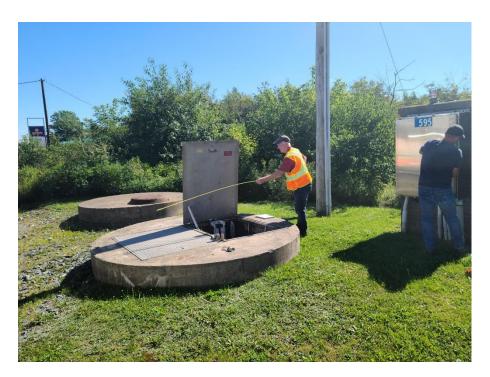
LS #8: Mill – Site

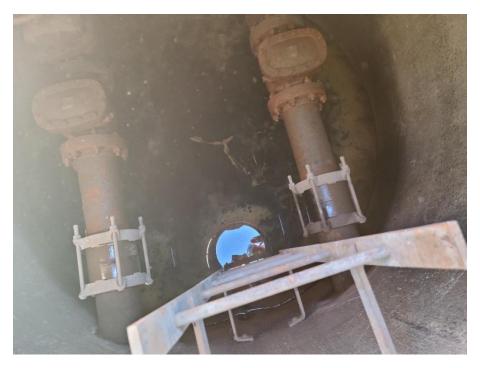
LS #8: Mill - Inside of Valve Chamber

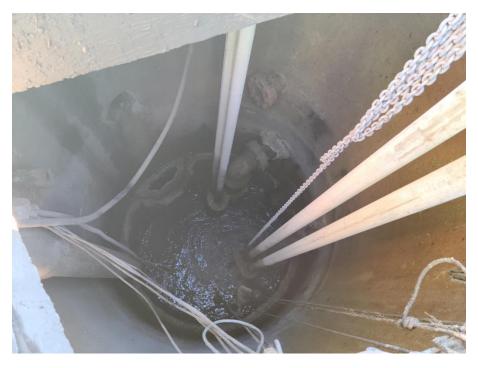
LS #9: Firehall - Inside of Wet-Well

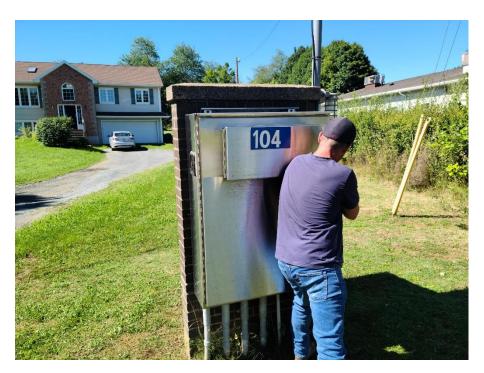
LS #10: Medical Centre - Pedestal and Control Panel Enclosure

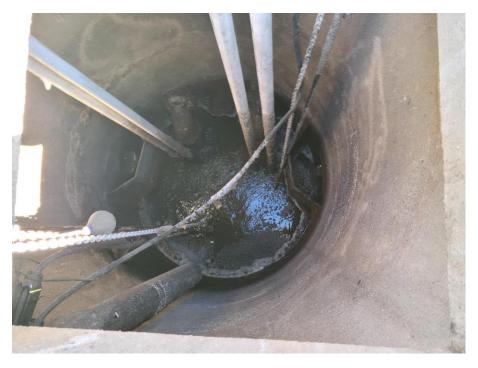
LS #10: Medical Centre - Inside of Wet-Well

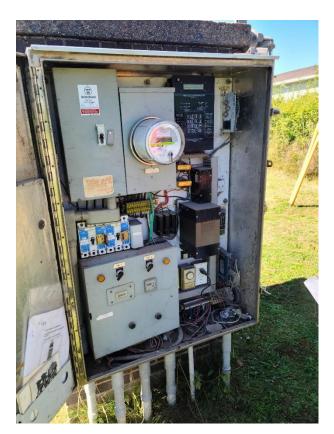
LS #10: Medical Centre - Control Panel

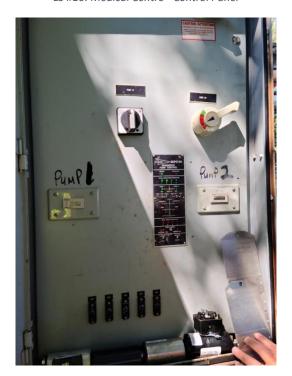
LS #10A: Pine Grove: Control Panel

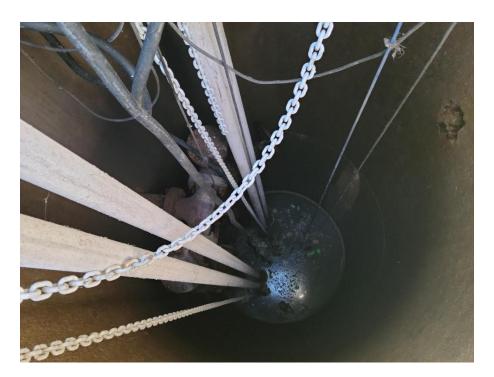
LS #10A: Pine Grove - Inside of Wet-Well

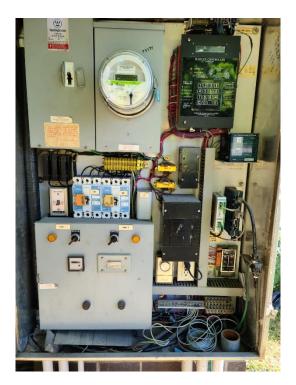
LS #11: Old Elmsdale School - Control Panel

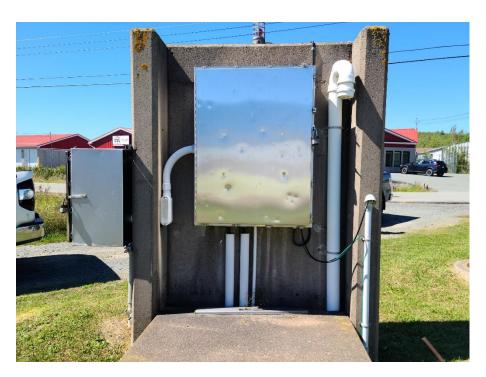
LS #11A: Industrial Park - Pedestal and Control Panel Enclosure

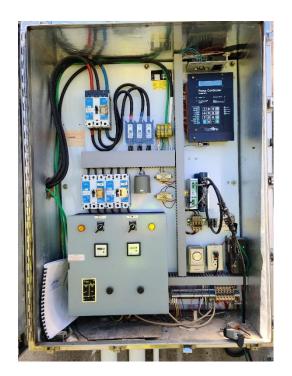
LS #11A: Industrial Park - Control Panel

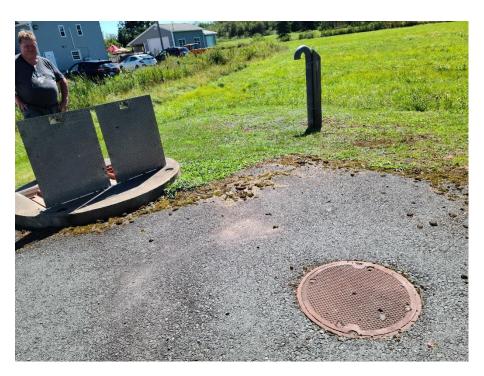
LS #11B: Carmies Daycare - Valve chamber and wet-well

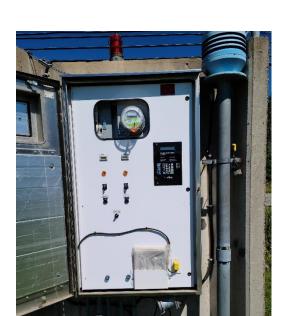
LS #11B: Carmies Daycare - Control Panel & Pedestal

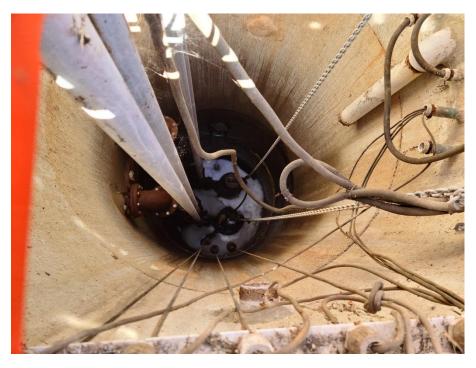
LS #11B: Carmies Daycare - Inside of Wet-Well

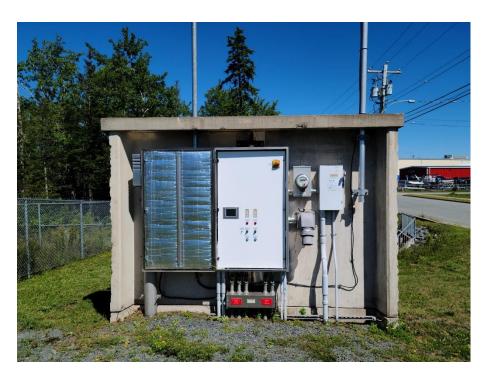
LS #11C: Park Road Extension - Pedestal & Control Panel

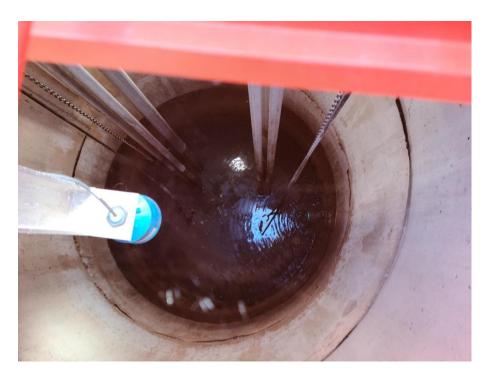
LS #11C: Park Road Extension - Inside of Wet-Well

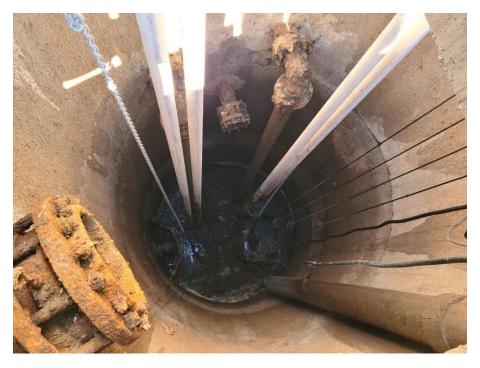
LS #12: Elmsdale Legion - Inside of Wet-Well

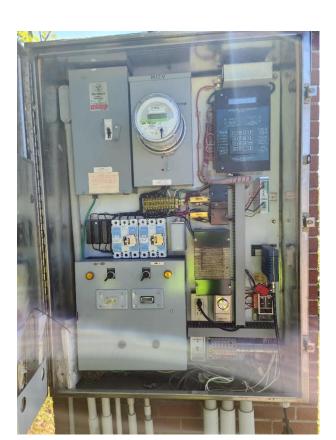
LS #12: Elmsdale Legion - Control Panel

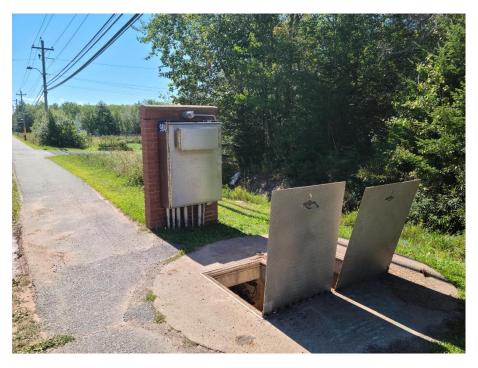
LS #13: Lantz Cemetery – Site

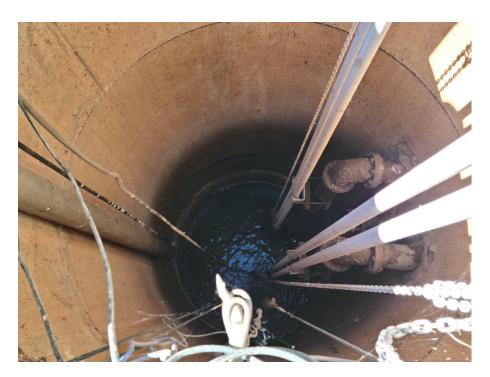
LS #13: Lantz Cemetery - Inside of Wet-Well

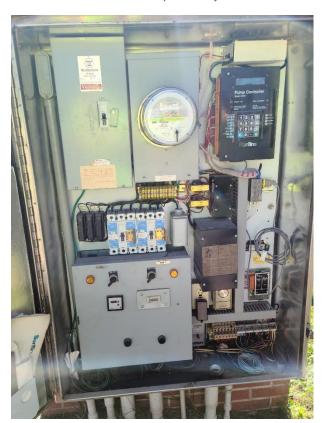
LS #13: Lantz Cemetery - Control Panel

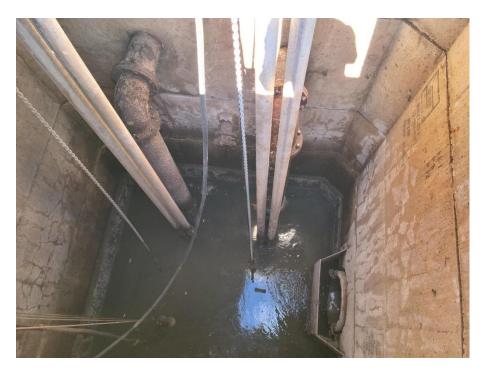
LS #14: Sportsplex - Inside of Wet-Well

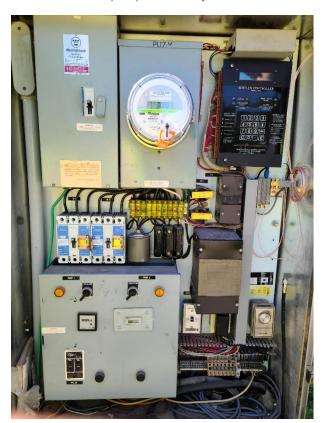
LS #14: Sportsplex: Control Panel

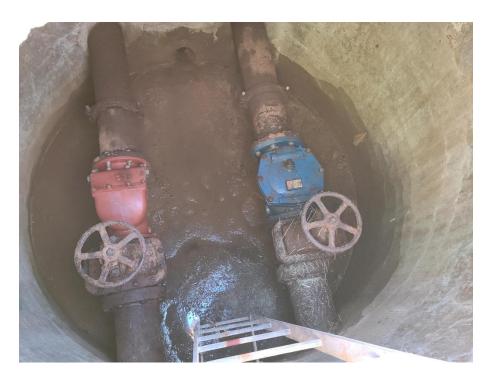
LS #14: Sportsplex - Inside of Valve Chamber

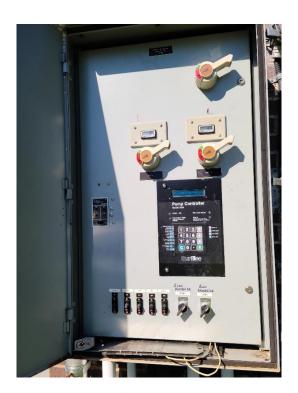
LS #15: Poplar Drive - Control Panel

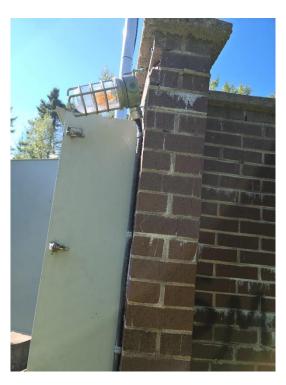
LS #15: Poplar Drive - Pedestal with hanging alarm light

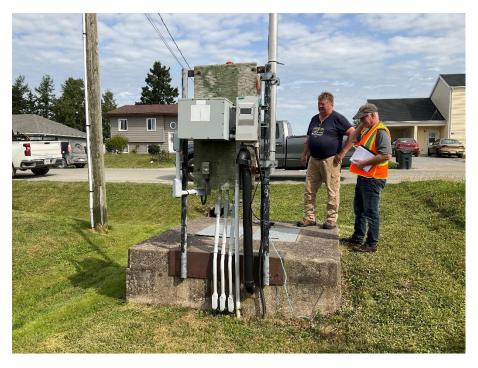
LS #22: Havenwood Road - Conduit from wet-well to control panel

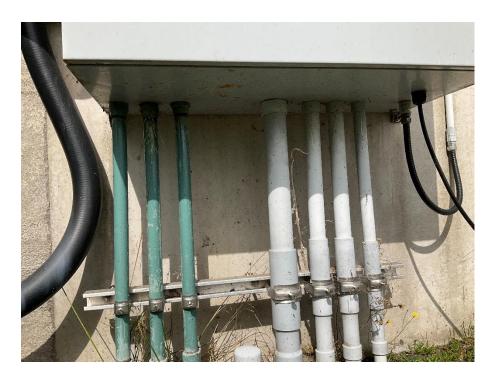
LS #23: Maitland Road: Conduit entering control panel

23	2848A Highway 2 SHI	J Maitland Road	NP 3153.181	2009	NP 3153.181	2009	2022	20-25	1992	30	?	30-35				\$7,500.00	\$7,500.00	Install explosion proofing. Replace lock on valve chamber cover
24	44 Burgess Road SHI	J Burgess Road	NP 3153.181	2009	NP 3153.181	2020	2020	20-25	?	30	2010	30-35					\$0.00	No repairs needed.

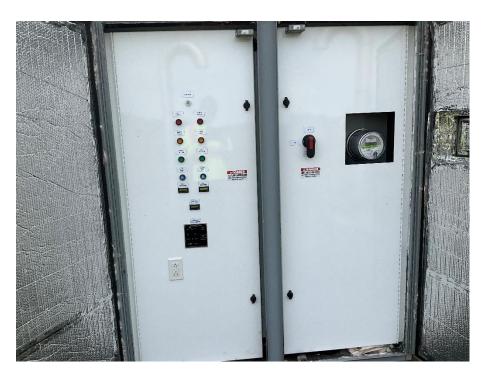
LS #24: Burgess Road – Monitor Panel and Power Meter
